Identifying Housing Maintenance Needs

DEFECT RECOGNITION HANDBOOK

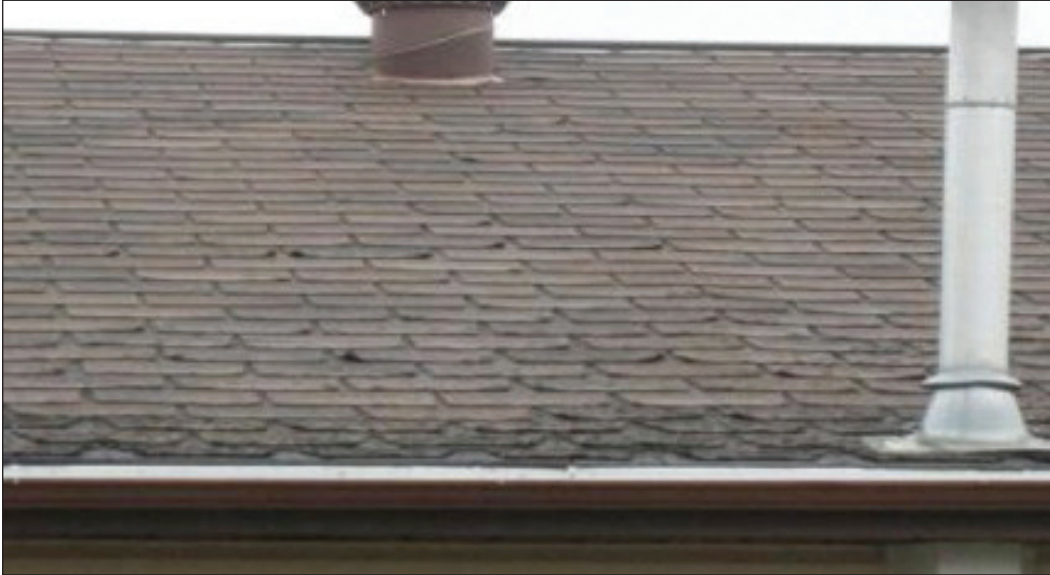
Defect Recognition – slide 2-01

These roof shingles are deteriorated (curled edges, missing or broken shingles) and have reached the end of their useful life. The roof shingles should be replaced. If not replaced, the roof will start to leak.

The age of the roof, along with the sun, wind and snow, has damaged the shingles over time, making them brittle and curling them (normal wear and tear).

Remove and dispose of the existing shingles and replace any moisture-damaged roof decking material. Install a new roof, starting with ice and water shield at the eaves, building paper underlayment where required, a new drip edge and flashing, roof shingles, roofing vents, ventilation fan hoods, and plumbing flanges, all installed in accordance with manufacturer's instructions.

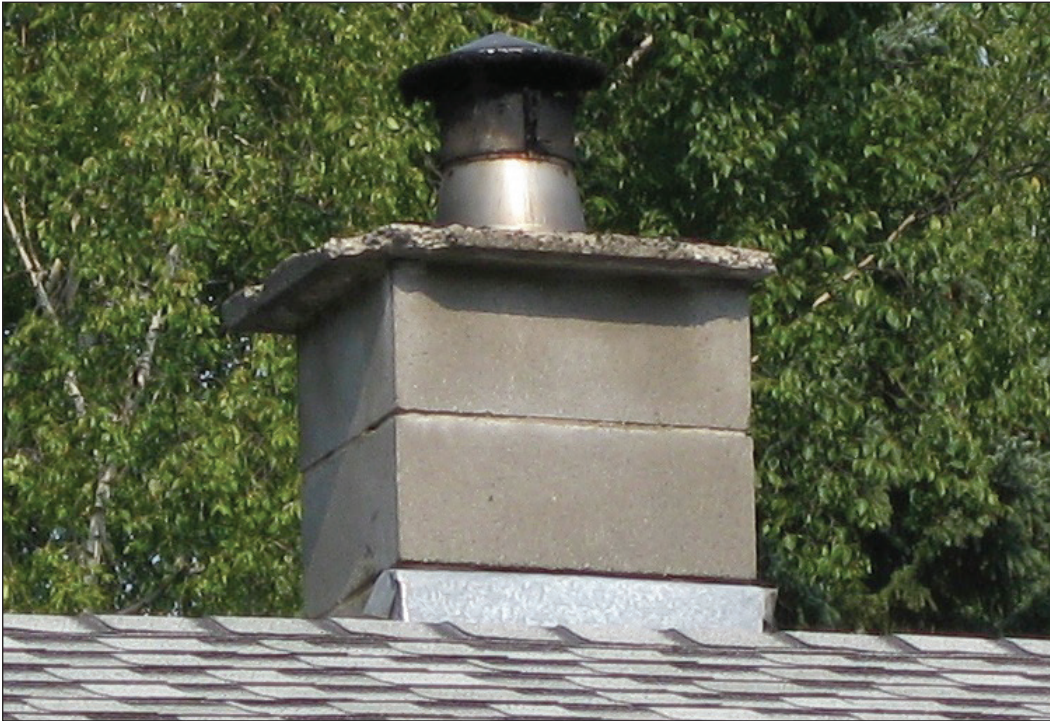
Defect Recognition – slide 2-02

The concrete chimney cap on top of this masonry chimney has deteriorated. If left much longer, rainwater will seep into the chimney itself, damaging it and possibly interior finishes.

The age of the chimney cap, along with acidic chemicals from the chimney exhaust gases, and the freeze-thaw cycle have broken down the strength of the concrete.

Remove the old concrete chimney cap and upper chimney flue pipe. Install a new upper chimney flue or a complete new metal chimney liner. Build a wooden form and pour a new concrete cap about 100 mm (4 in.) thick and higher in the middle around the metal chimney pipe to provide a slope away from it. Provide for rain drips on the underside of the chimney cap to shed water away from the chimney.

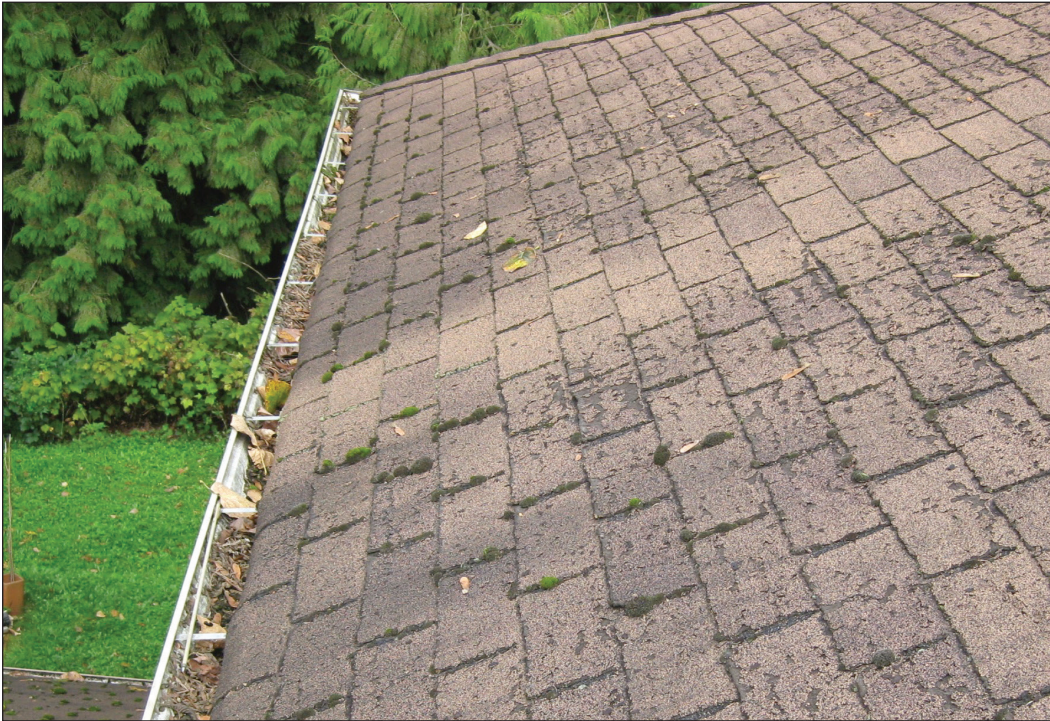
Defect Recognition – slide 2-03

The eavestrough is full of leaves and twigs, and likely the downspouts will be blocked as well. These obstructions will prevent the proper drainage of water from the roof and away from the foundation. Overflowing eavestroughs could lead to water getting into eaves and soffits and causing damage to the wall areas below.

This is a normal recurring condition, due to the leaves that fall every year.

At least once a year, preferably in the late fall, the eavestrough and downspouts should be cleared of leaves, twigs and other debris collected in the eavestrough. Collect the debris into a bucket and then spray out the eavestrough and downspouts with a water hose that has good pressure, and ensure the water is properly draining from the downspouts.

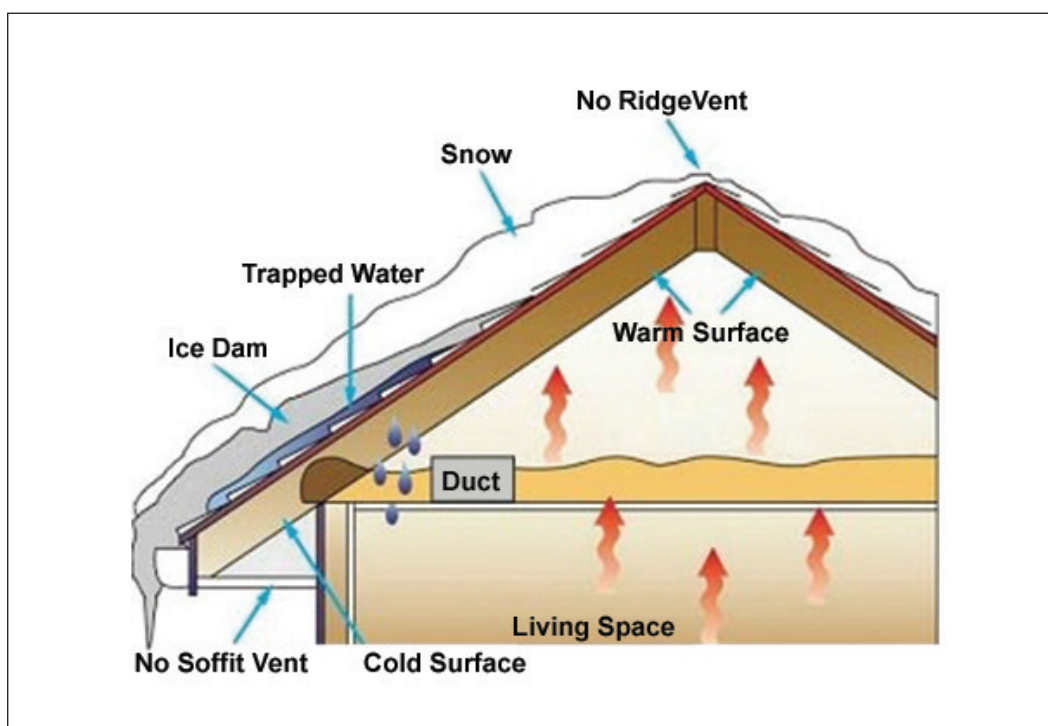
Defect Recognition – slide 2-04

“Ice damming” is the buildup of ice along the lower slope of the roof, as shown above. If not corrected, it can cause water to leak under the shingles and into the house.

Ice damming is caused by snow melting on the roof surface due to a buildup of heat in the attic space caused primarily by heat escaping from the living area below into the attic space and, secondly, by insufficient ventilation of the attic space. As the snow on the roof surface melts, this water runs further down the roof slope until it hits the colder portion of the roof above the overhang. There it freezes and builds an “ice dam,” which can send a thin slab of ice a significant distance up the roof slope. Trapped water from the snowmelt then gets under the shingles and leaks into the house along the exterior wall, often coming in along the top of the windows.

Reduce air leakage into the attic space wherever possible (weather-strip the attic-hatch lid and make sure the bathroom exhaust fan is not vented into the attic space) and ensure sufficient ventilation of the attic space (soffit/roof/ridge vents). When hiring contractors to add insulation in your homes' attics, make sure that they do not block off the existing soffit ventilation areas.

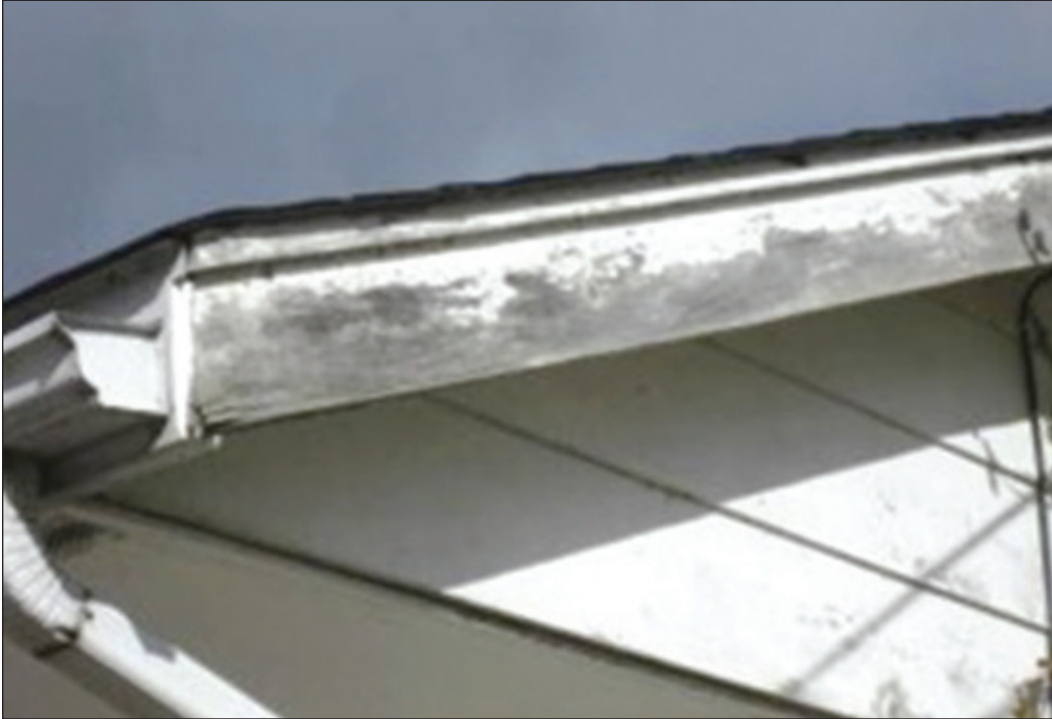
Defect Recognition – slide 3-01

The paint has worn off of the fascia board. As the wood absorbs the rainwater, it gets wet and begins to rot.

Paint will break down with age, primarily as a result of ultraviolet rays from the sun. Then water will soak into the unprotected wood and cause the wood to rot, as is evident in the lower edge of the fascia board near the eavestrough.

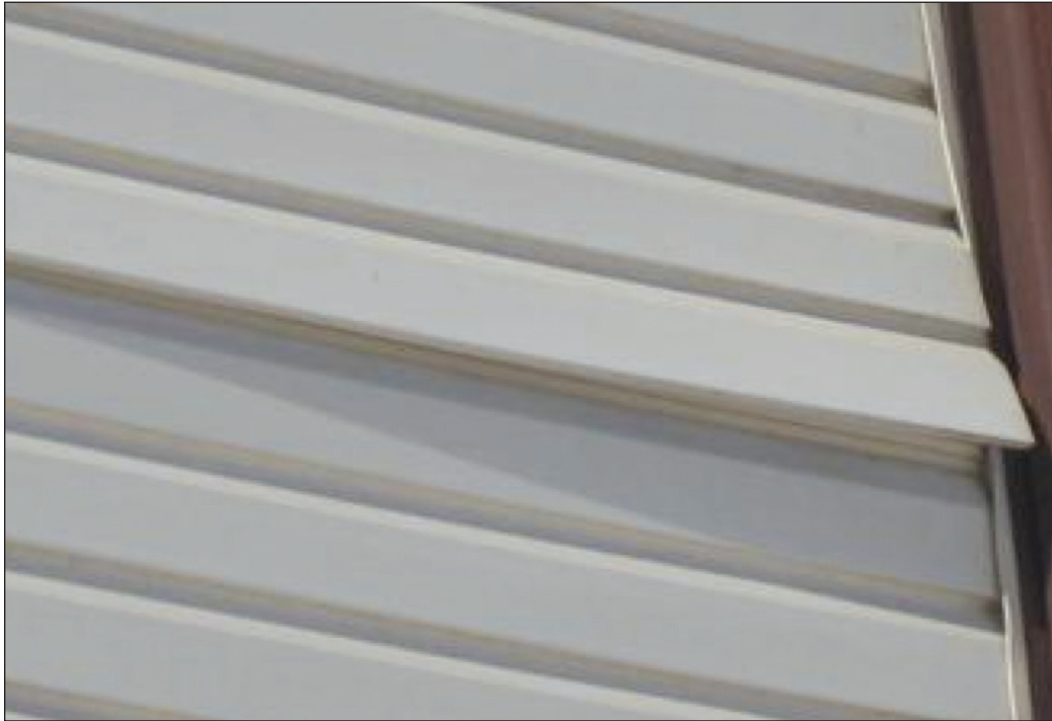
Defect Recognition – slide 3-02

The vinyl siding has come loose. If not resecured soon, the wind will rip this piece of siding, and perhaps many others, off the wall.

As the sun shines on the vinyl siding, it expands. As a result, loose joints will become even looser, sometimes causing the joints to open or unhook from the sheet below.

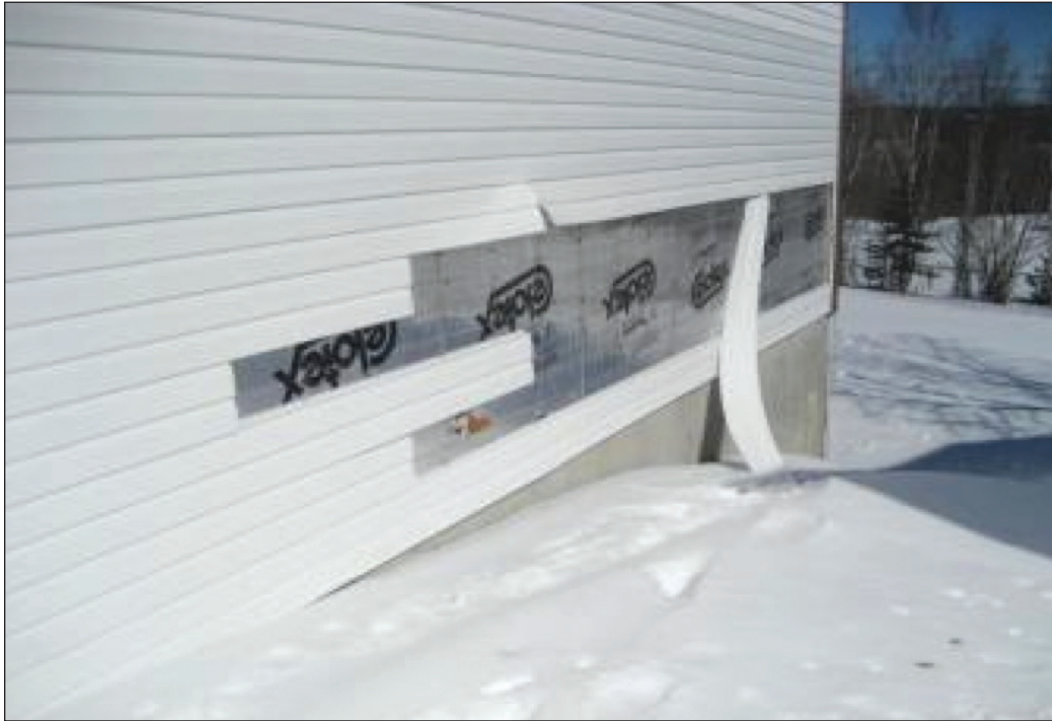
Defect Recognition – slide 3-03

Vinyl siding has been ripped off the exterior wall.

Find or buy additional vinyl siding, with matching colour and texture, and replace the missing pieces. Ensure that each sheet is securely hooked up into the joint below and “hung” securely with nails sufficiently long enough to penetrate into the framing members behind the sheet insulation.

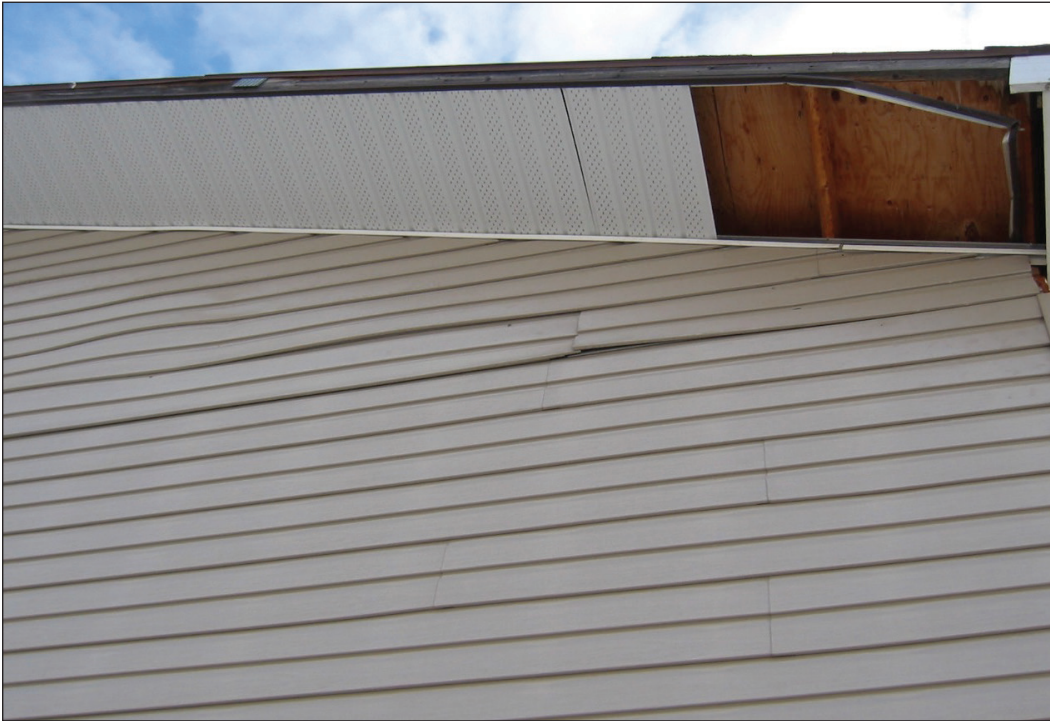
Defect Recognition – slide 3-04

Aluminum vented soffit is missing on this gable end of the house.

Find or purchase matching soffit. Replace the missing pieces and finish the installation of aluminum fascia to complete the job and protect the soffit ends from high winds.

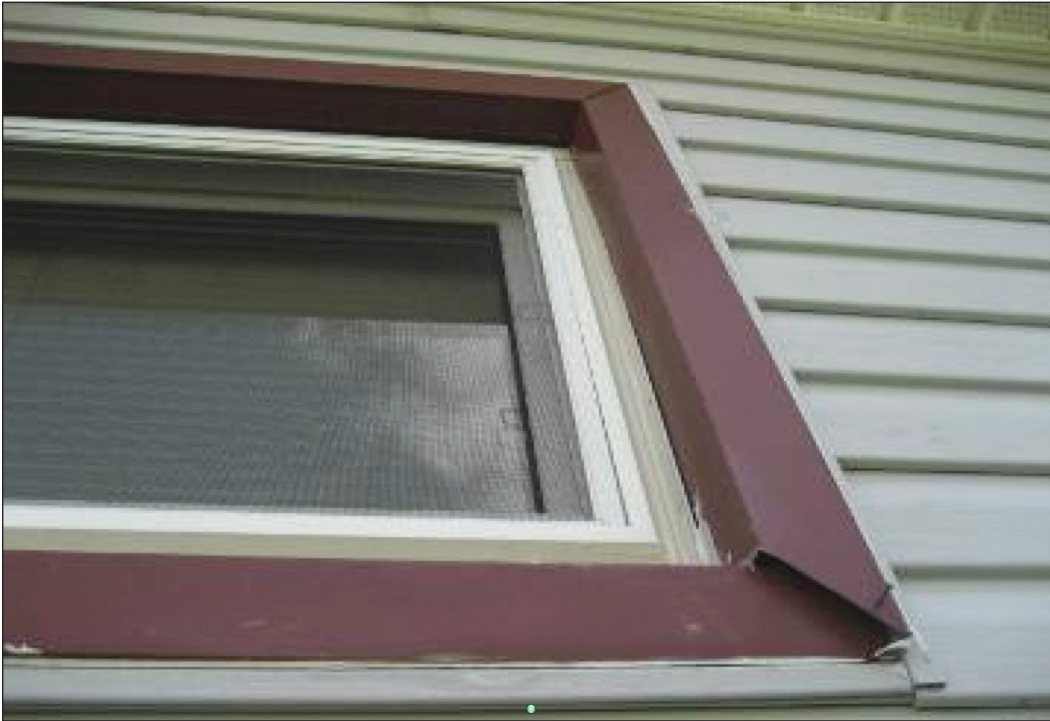
Defect Recognition – slide 3-05

The aluminum flashing (capping) around this window frame has come loose at the mitered joint, causing the caulking joint between the flashing and the window frame to open as well.

This was probably an installation of a new window insert into an existing window frame. Then the pre-existing wood frame was capped with aluminum flashing. It could be that the old wood was a bit “spongy,” and then the finishing nails did not hold as well as they should have and came loose.

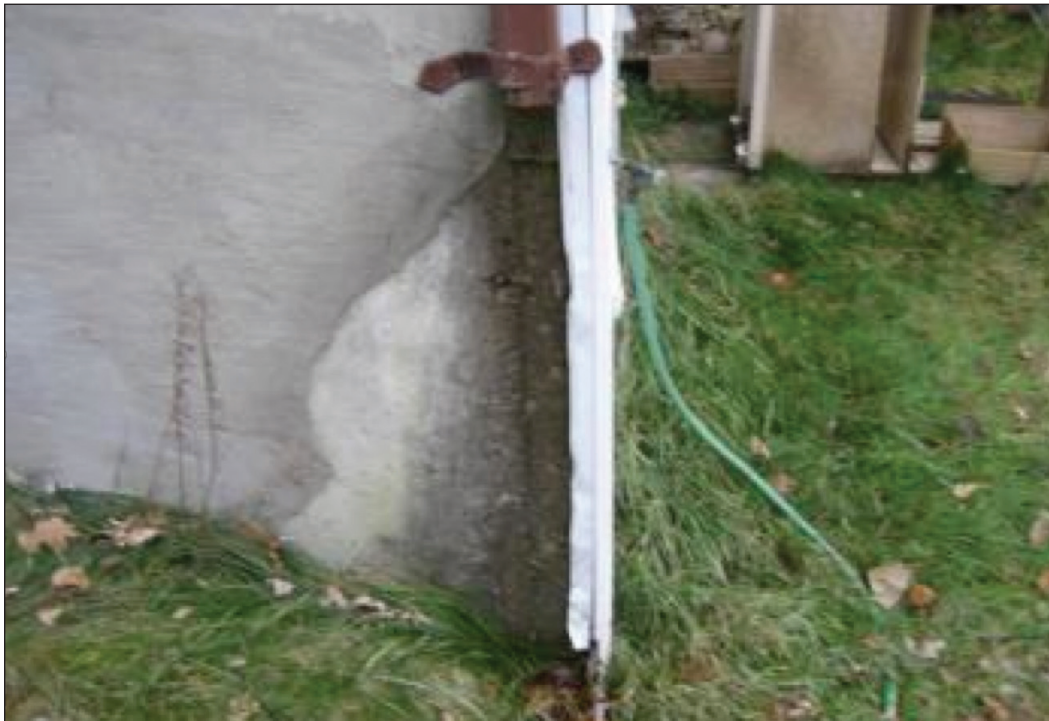
Defect Recognition – slide 3-06

The cement parging has broken off the foundation wall at the corner of the house and the wood trim on the adjacent framed wall (walkout basement) appears to have rotted. The lower part of the downspout is missing. If not repaired, the wood will continue to rot and water may enter the basement through the foundation wall.

The lower part of the downspout, which directs water away from the house, is missing and eavestrough water has been running down the foundation wall. The freeze-thaw cycle has caused the cement to break away and leave the foundation wall exposed at this area. Water, both from the downspout and from contact with the soil, has also soaked into the adjacent wood corner trim, which in turn has started to rot.

Remove any loose cement parging on the concrete foundation wall and repair the damaged area with new parging. Replace the rotted wood corner trim and paint it. Keep the wood trim at least 200 mm (8 in.) above grade. Install a new downspout to just above the ground and an extension pipe to take the water away from the foundation.

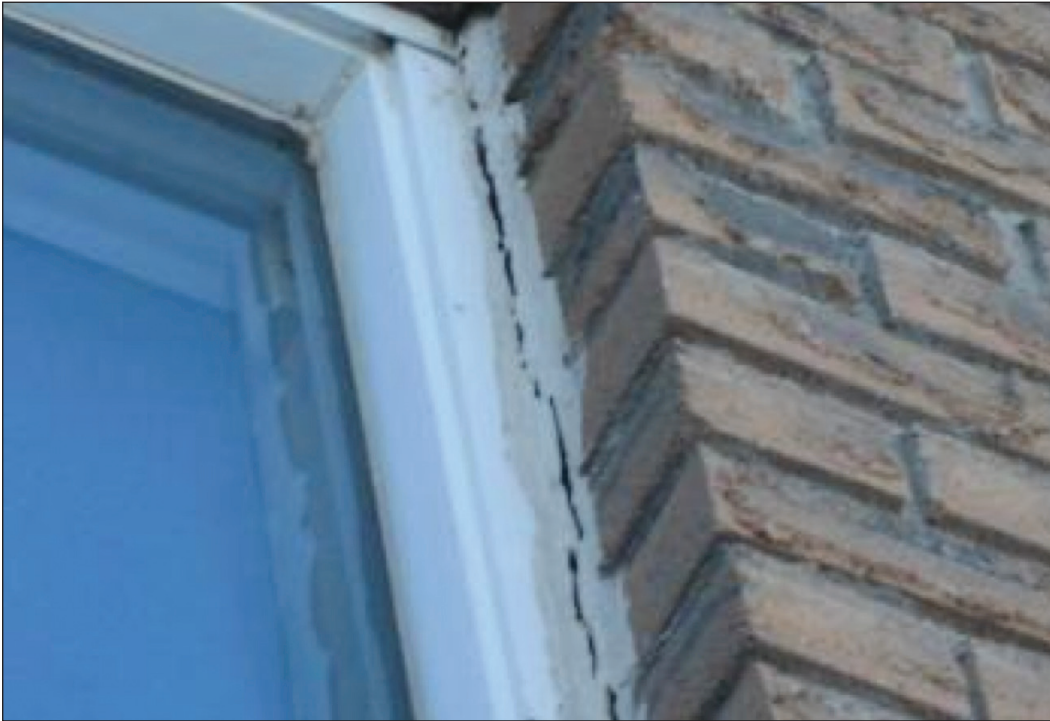
Defect Recognition – slide 3-07

The caulking between the window frame and the masonry wall has become hard, brittle and cracked, which will allow rainwater to enter the building envelope and cause mould or rotting of the wood framing.

Age, weather exposure and sun damage (ultraviolet light) will deteriorate the caulking and cause it to become hard, brittle and crack.

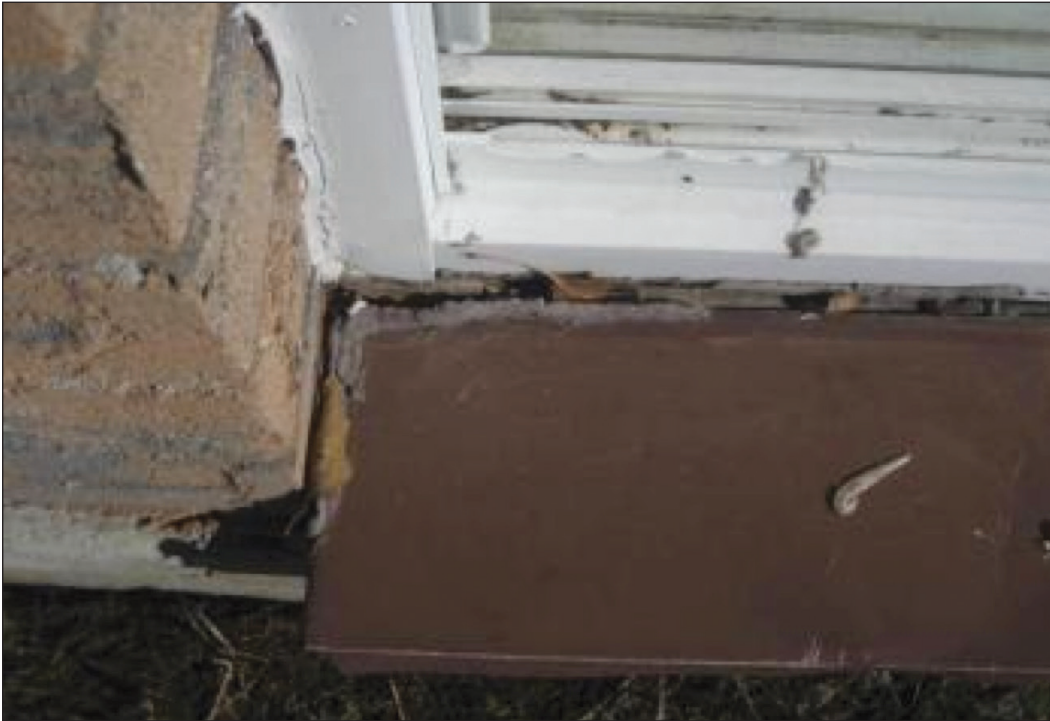
Defect Recognition – slide 3-08

You are looking at the sill of a basement window. The caulking has become hard, brittle and cracked, allowing water to get into the joint.

Age, weather and sun damage (ultraviolet light) has caused the caulking to become hard, brittle and crack. Rainwater getting into that joint in winter will freeze and expand, causing the sill to push further away from the window. And, any rainwater entering the building envelope can cause mould or rotting of the wood framing.

Remove the sill. Clean away the old caulking from the window. Replace the sill if it is rotted wood; or at least clean away all old caulking and refasten it into place against the window and recaulk the joint with silicone caulking.

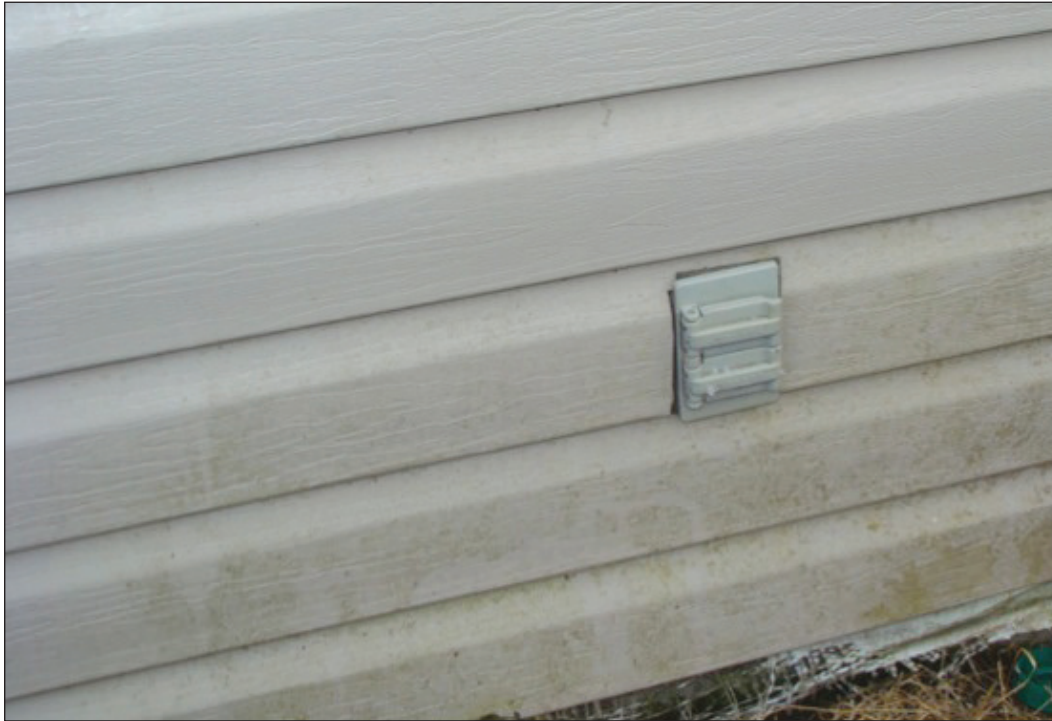
Defect Recognition – slide 3-09

There is a gap between the vinyl siding and the electrical receptacle cover. This can allow rainwater to enter into the receptacle and cause an electrical short. And it could even allow water to enter into the wall cavity, causing mould or wood rot.

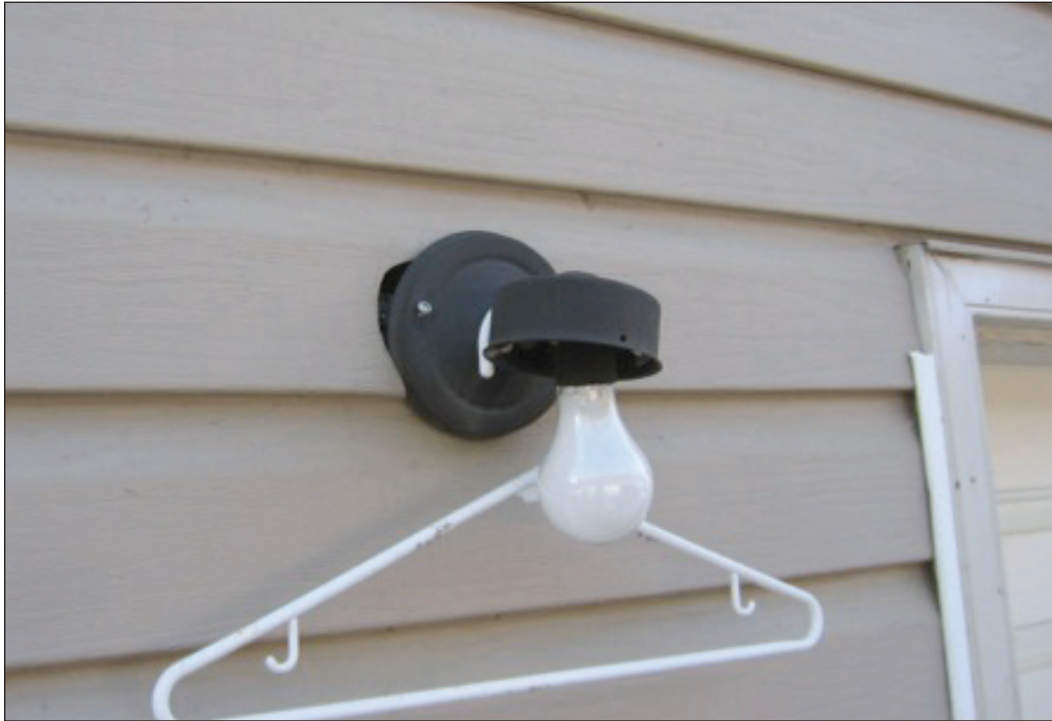
Defect Recognition – slide 3-10

There is a gap between the vinyl siding and the base of the light fixture. This gap will allow wind-driven rainwater to get into the electrical box and behind the siding.

Since the light fixture is also damaged, buy another light fixture with a larger base that will cover the gap and then caulk the opening between the base and the siding.

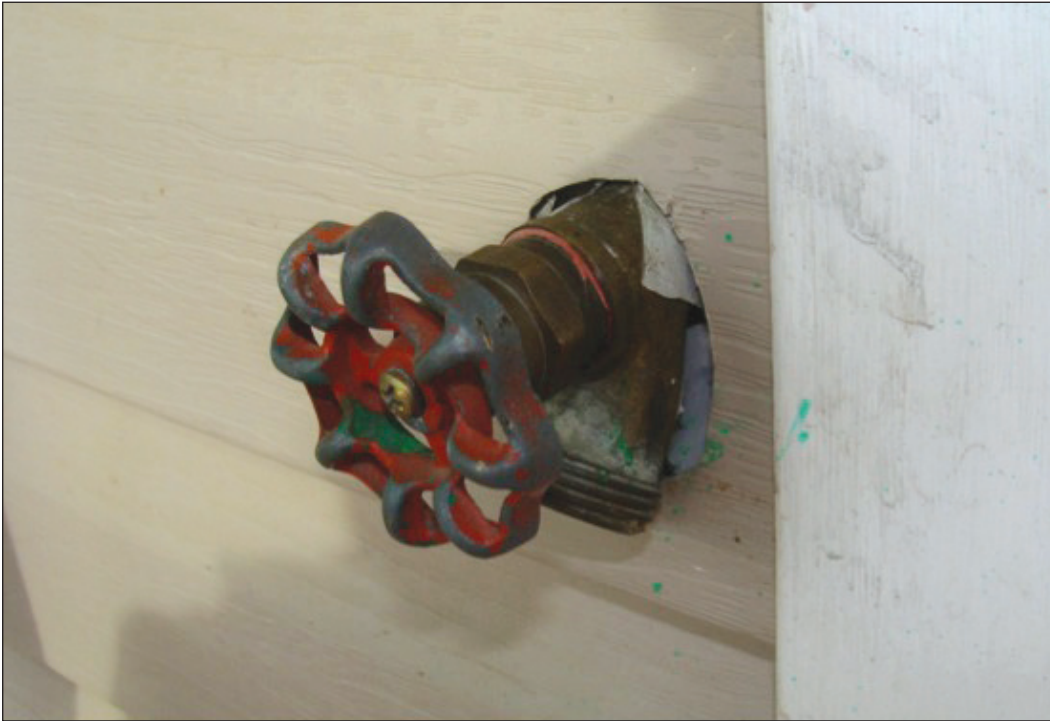
Defect Recognition – slide 3-11

Aside from this water tap not being a frost-protected tap, the tap is now too close to the siding to allow a hose to be easily attached. There is also a gap around the siding cut-out for the tap, which could allow rainwater to enter the building envelope.

However, since the tap is too close to the wall, a better solution would be to remove this tap; patch the existing hole with a piece of vinyl siding; and then drill a smaller opening to install a new frost-protected hose bib (tap). The new tap has a flange that can be screwed to the wall. When the installation of the tap is complete, caulk any remaining gap between the tap flange and the vinyl siding.

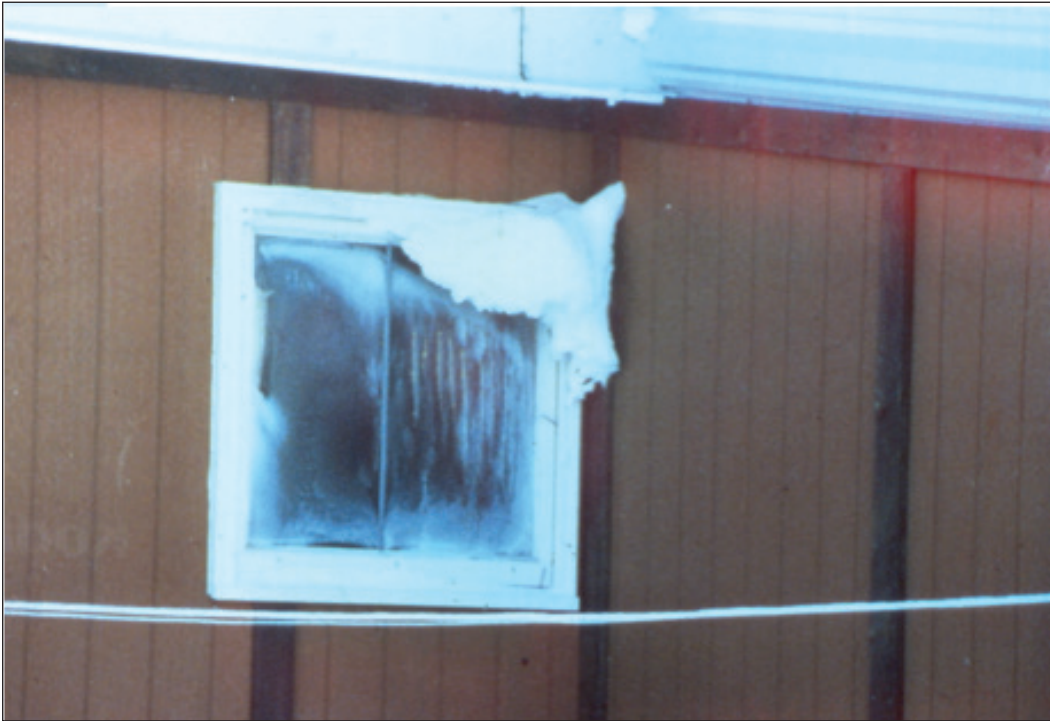
Defect Recognition – slide 3-12

While an extreme example, here we see a frost plume on the outside of a window.

There is likely no insulation and no air seal of the rough opening between the window frame and the wall (at least at the upper right corner of the window) resulting in warm moist air from inside the house leaking out, condensing and freezing on the cold exterior trim surfaces.

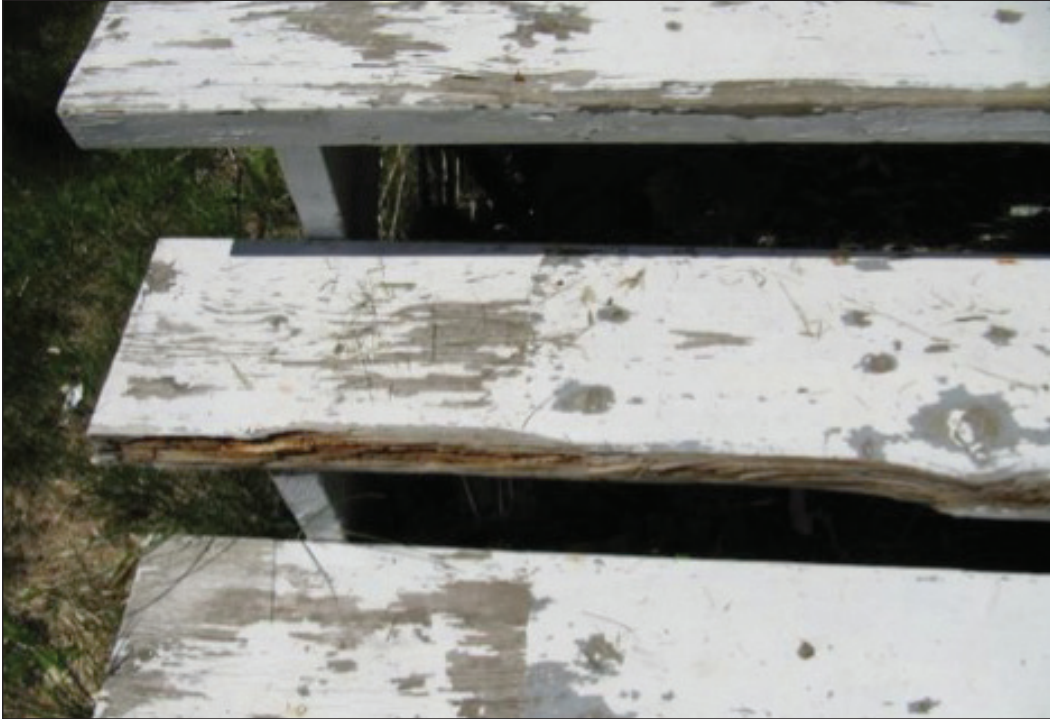
Defect Recognition – slide 4-01

The protective paint has worn off the steps. Now the treads are rotting and breaking away causing a potential fall hazard to the occupants and visitors. (There also appears to be no railing.)

The protective paint has worn off allowing moisture from rain and/or snow to soak into the wooden treads, causing them to rot and break away.

Damaged and rotten treads are to be replaced and painted or stained to prevent moisture from soaking into the wood. In this case, it might be best to replace the whole stairs, install a proper railing and stain or paint all of it.

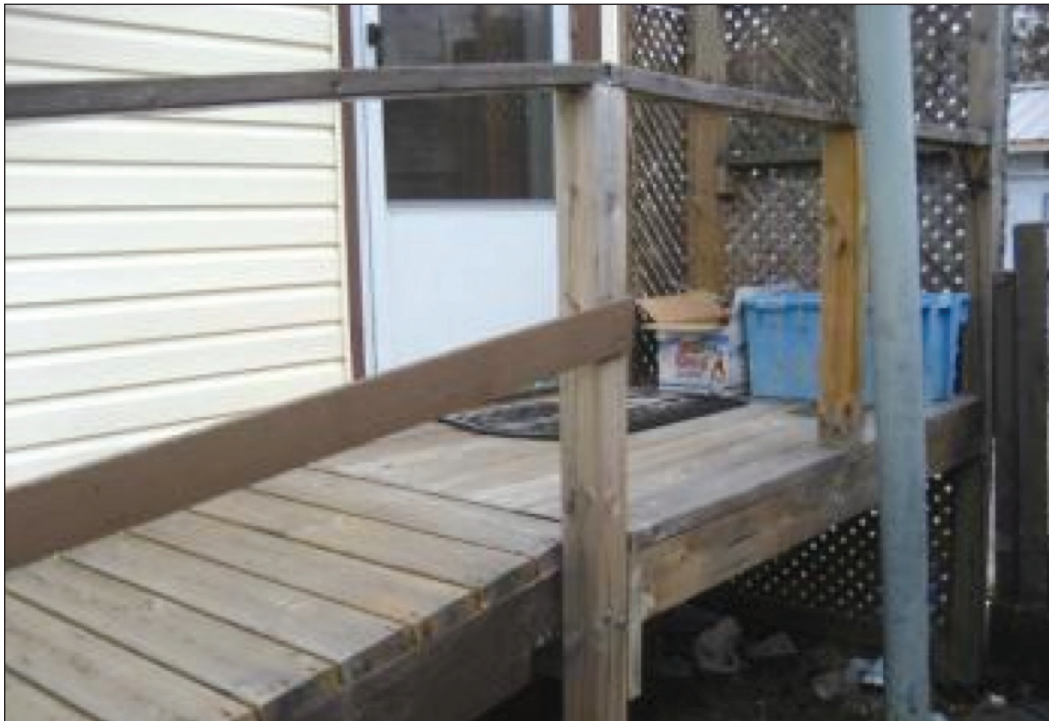
Defect Recognition – slide 4-02

Given the height of this landing and ramp off the ground, it does not have an adequate railing system.

The existing horizontal rails should be removed and a new railing system with upright, vertical posts and guard-rails should be installed in accordance with Building Code requirements. All new or unprotected wood should be stained or painted.

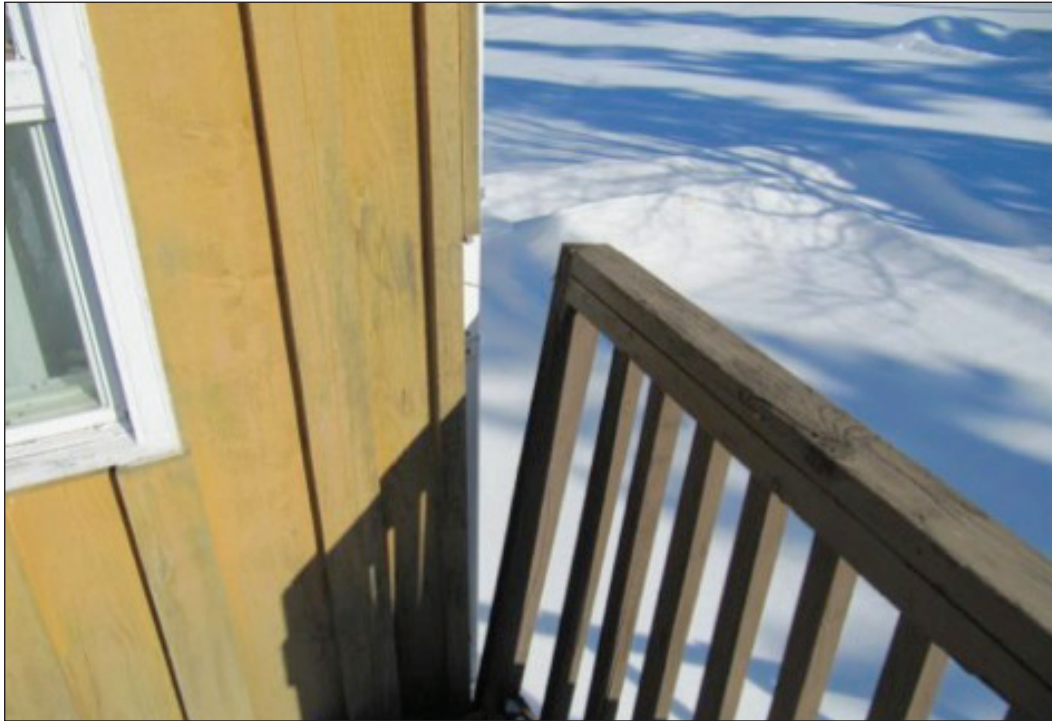
Defect Recognition – slide 4-03

The railing has come loose from where it was attached to the exterior wall, causing a potentially dangerous situation.

First, check that the bottom of the post is not rotten or broken. If it is, replace it. Next, install a metal corner bracket screwed into the railing and into the wall, securing the top of the railing solidly to the wall.

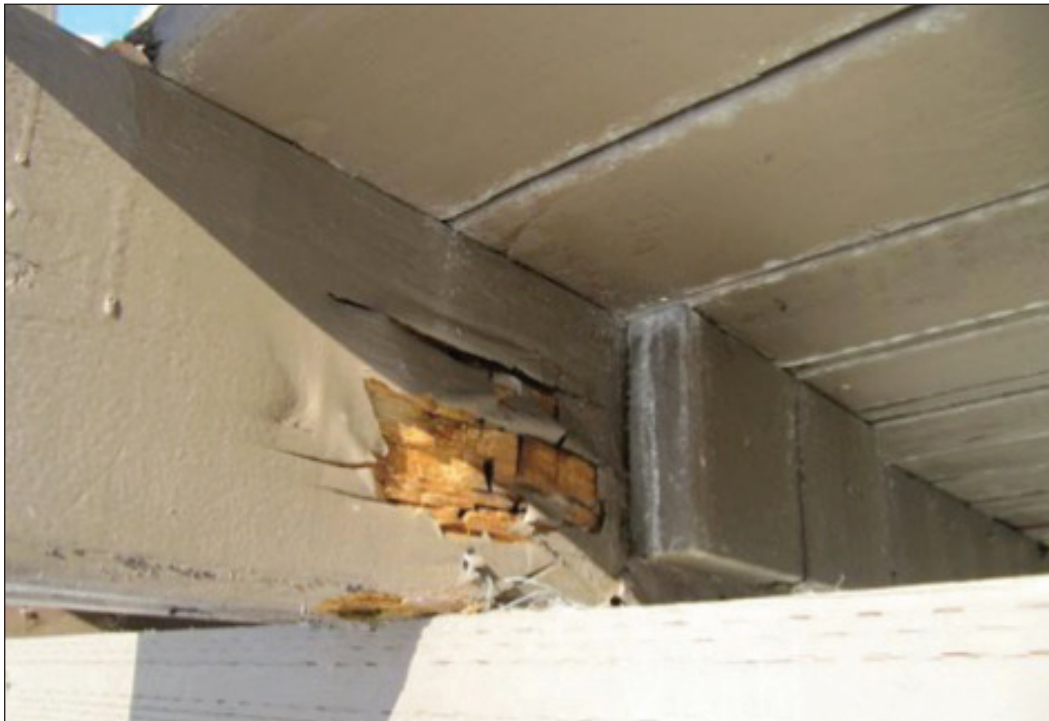
Defect Recognition – slide 4-04

This picture shows an area of serious wood rot or dry rot.

There was no eavestrough installed on the roof edge above this deck and the water collected by the roof continuously dripped down on the deck at this location. Once previous coats of paint deteriorated, it allowed the deck joists at this point to absorb the water and begin to rot. Additional coats of paint could not adhere to this wet location and the rot continued unabated over many years.

This deck joist, and others like it, will need to be replaced. That being the case, the complete deck should be examined as to whether it can be partially saved or should be totally replaced at this time. The restaining or repainting of decks, railings and stairs should be done on a cyclical basis, perhaps every five years, if possible, to ensure they remain water-resistant. Also, give consideration to installing an eavestrough.

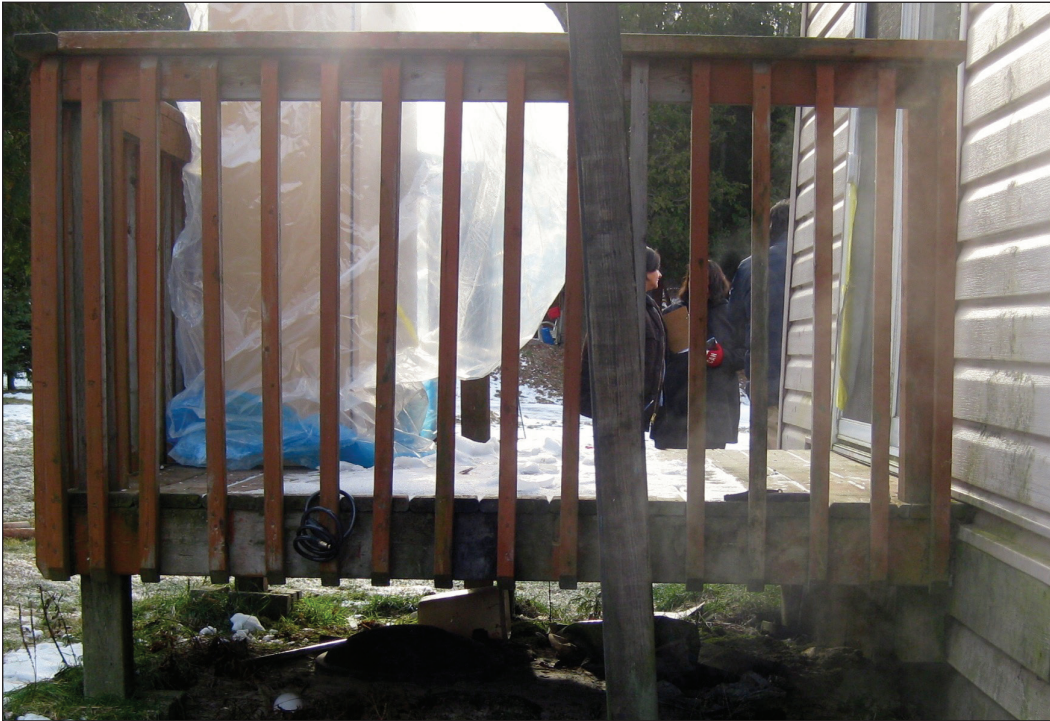
Defect Recognition – slide 4-05

The outer support (left side) is not stable, causing the deck to be lifted and dropped during and after winter.

While the right side of this deck is fastened to the house wall, which is supported by a permanent foundation; the left side is supported by deck blocks. Deck blocks are not a permanent foundation and they will rise and sink during the freeze-thaw cycle.

According to the Building Code, if a deck is fastened to the house, it should be supported by a permanent foundation on the other side as well. That would be concrete piles extending down to a depth below frost penetration in the area where the deck is built.

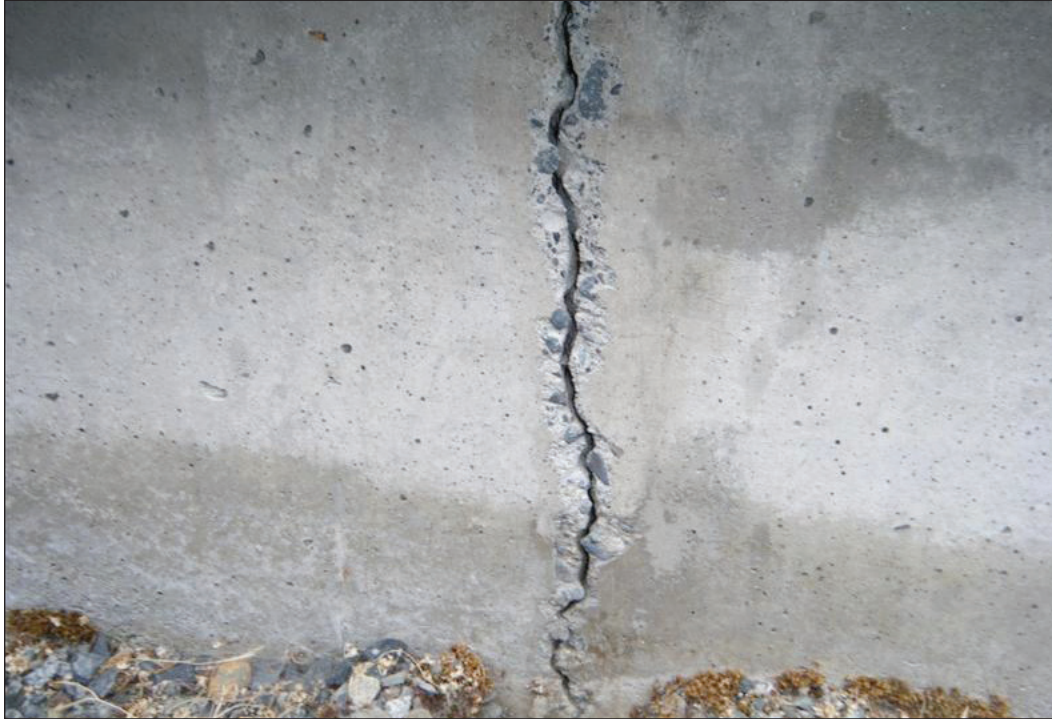
Defect Recognition – slide 5-01

Pictured above is a serious foundation crack, as seen from outside the house.

A primary cause of foundation cracks is unstable soil under part of the foundation footing. As that part of the footing sinks and settles, the uneven settlement creates a vertical crack in the foundation wall.

Monitor the crack to see if the settlement has stopped. You may need to hire a foundation specialist to stabilize the foundation first, possibly by underpinning a section of the footings.

When the foundation is stabilized, the crack only needs to be repaired if it is leaking water or if you are planning to finish the inside of the foundation wall. If the crack is leaking, dig it up on the outside, right down to the footing. Get a reliable contractor to chip it out to form a “V,” fill the crack with epoxy and waterproof the exterior of that section of wall with a product similar to a “System Platon” membrane.

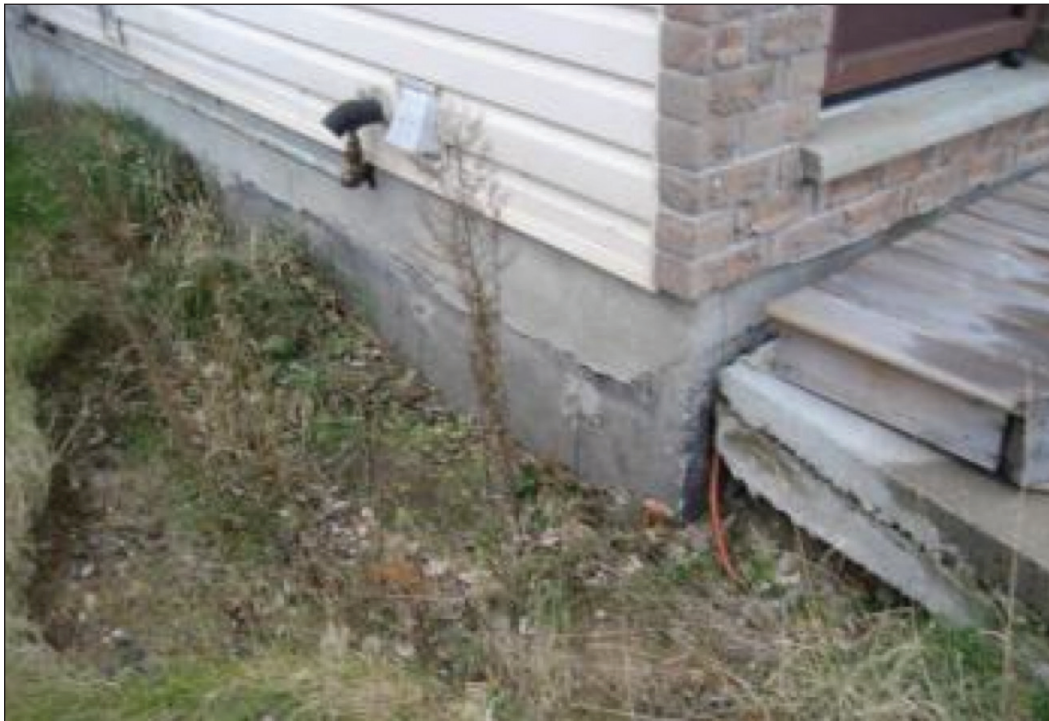
Defect Recognition – slide 5-02

An area beside the foundation has been washed out and has undermined the back entrance slab, causing it to sink.

The black pipe coming out of the wall is a sump pump drainpipe. It was not extended away from the foundation and, as a result, has washed out this area beside the foundation and even under the concrete rear entrance slab.

First, extend the sump pump drainpipe well away from the house. Remove the slab if possible, raise the level of the granular fill at the back entrance, replace the slab and level it.

Finally, regrade the area around the house, where necessary, to direct water away from the foundation.

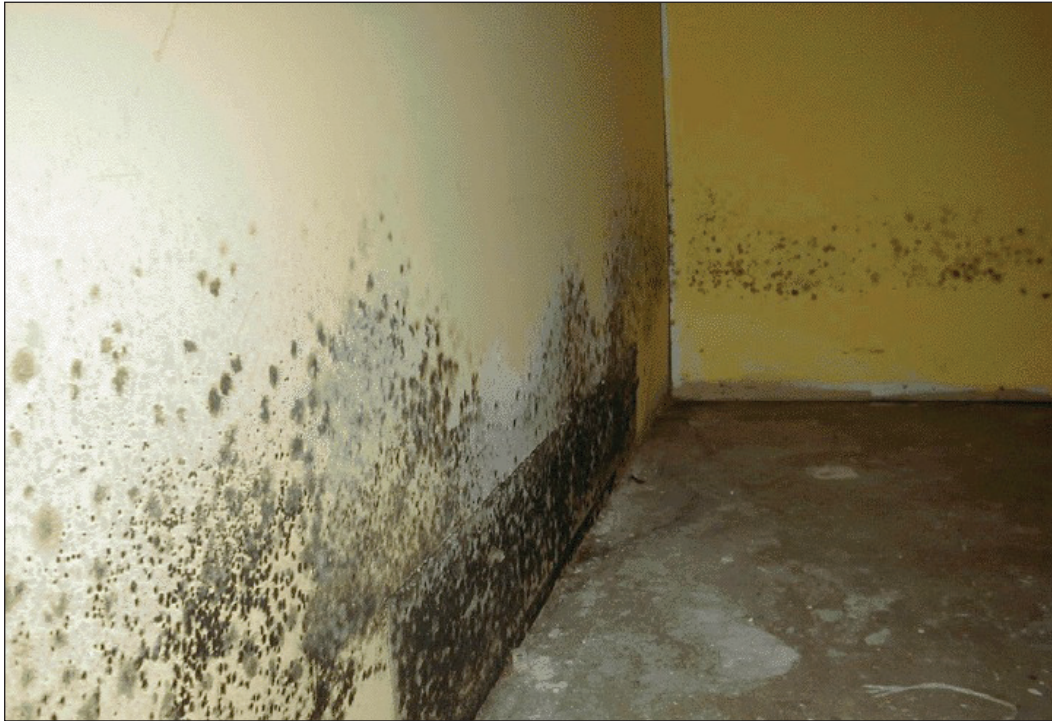
Defect Recognition – slide 5-03

This is the inside of a basement with serious mould growth on the drywall finish.

Since the mould is not up to a specific horizontal line all around the basement (there may have been a mattress or box against the left side wall), it is not due to a flooded basement. In this case, the problem is likely a blocked perimeter drain tile, which has saturated the lower portion of the foundation wall and caused mould growth at various interior locations.

Remove the interior finish on the lower half of the basement foundation walls, both to remove the mould and to further examine the wetting pattern on the walls. If there is significant moisture saturation in the lower half of all the perimeter walls, likely the exterior of the whole basement needs to be dug up to the bottom of the foundation footing. Clean the foundation wall, redo the dampproofing (waterproof if a concrete block foundation), install a new drain tile and crushed stone. Finally, backfill the excavated area with a free-draining granular fill. Note, if the house is in an area with a high water table, ensure there is a reliable sump pump system to collect the perimeter drain water and pump it away from the foundation.
