Identifying Housing Maintenance Needs

DEFECT RECOGNITION HANDBOOK

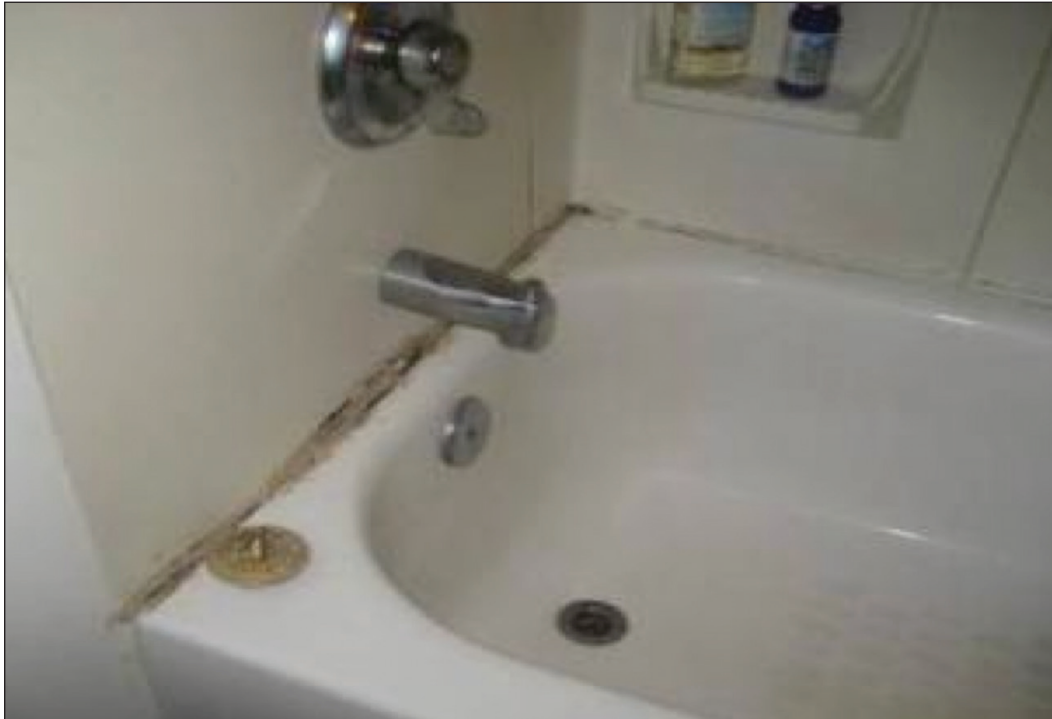
Defect Recognition – slide 6-01

The caulking around the lip of the tub has deteriorated and is getting mouldy.

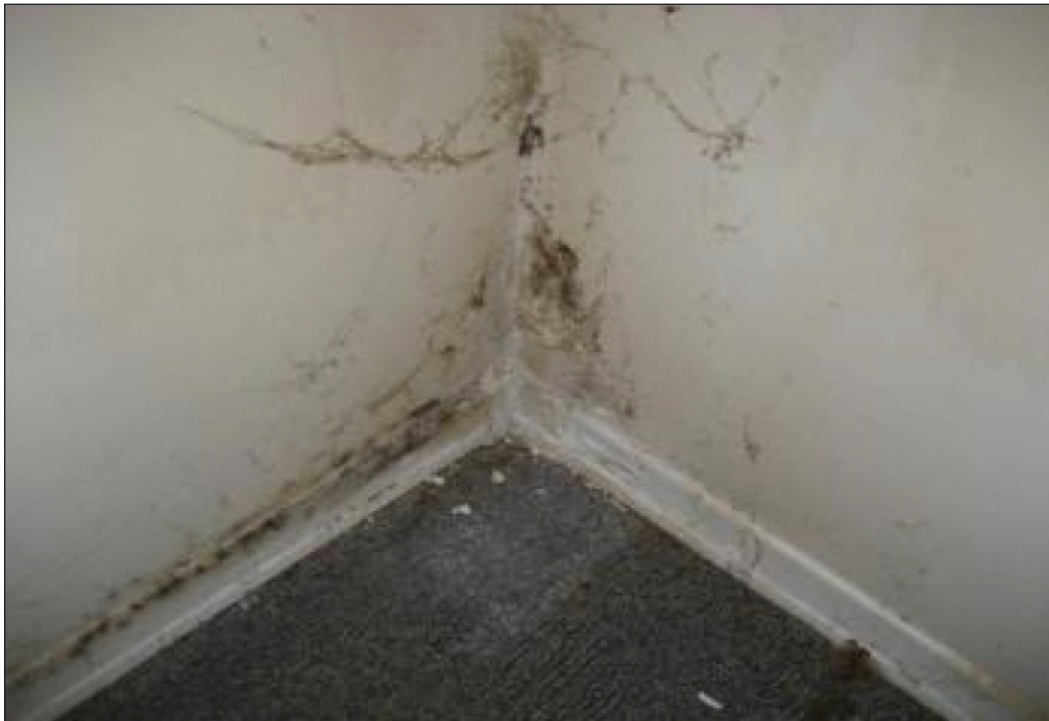
Defect Recognition – slide 6-02

Mould is growing in a lower corner of this room.

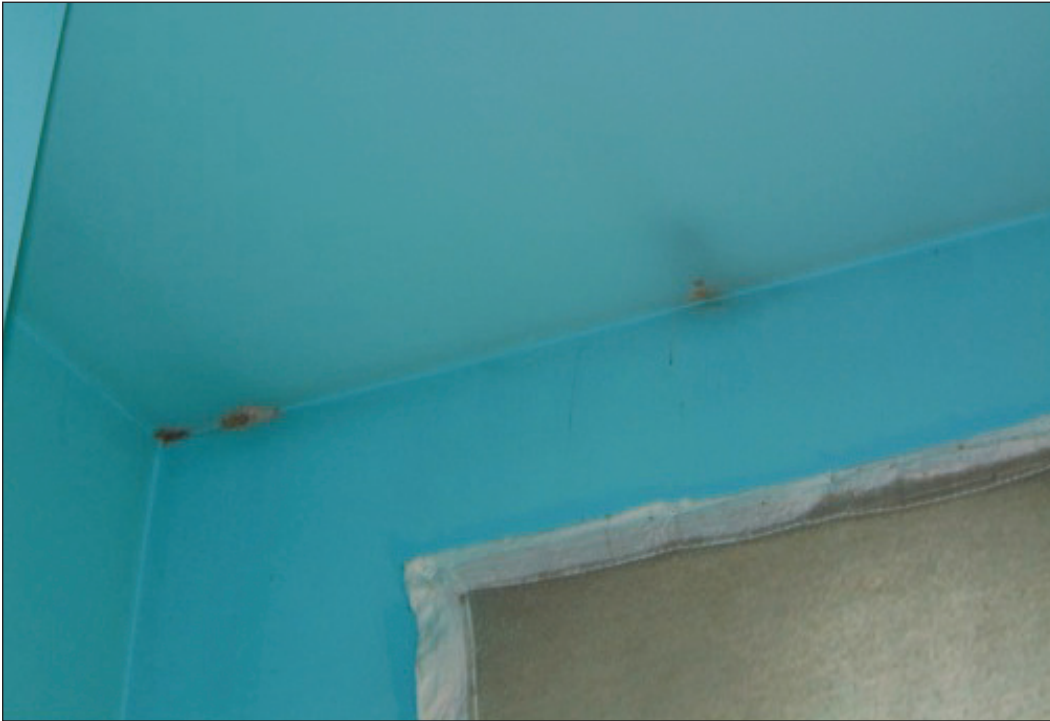
Defect Recognition – slide 6-03

These are mould spots in the corner where an exterior wall meets the ceiling.

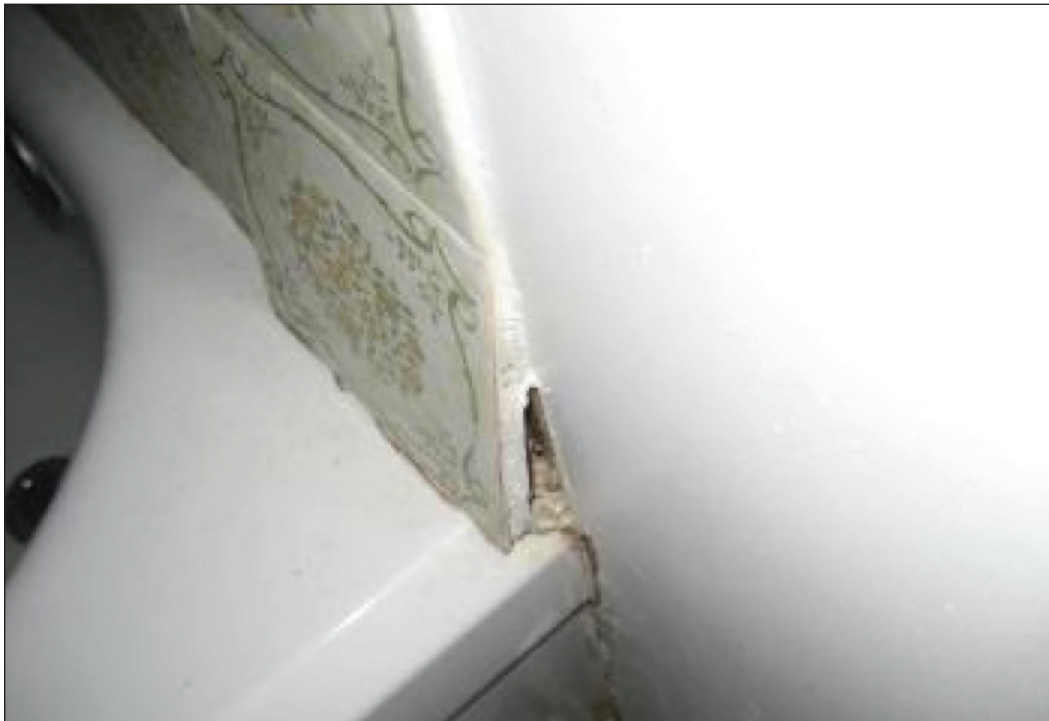
Defect Recognition – slide 6-04

A piece of ceramic tile along the ridge of the bathtub has come loose.

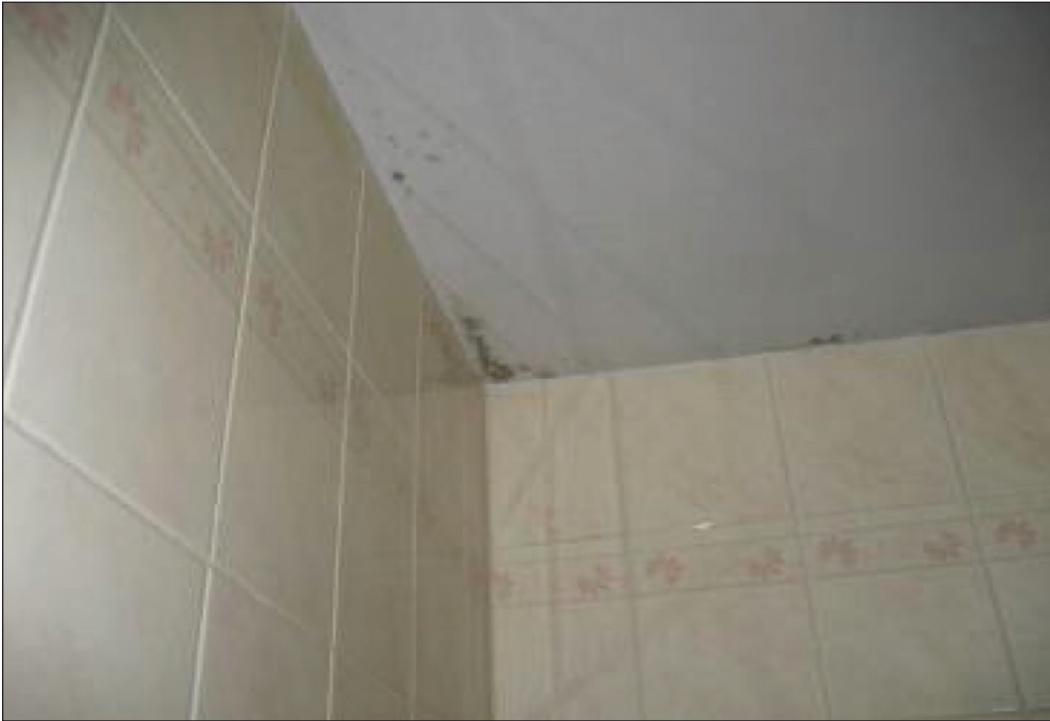
Defect Recognition – slide 6-05

There is some mould on the ceiling above the shower.

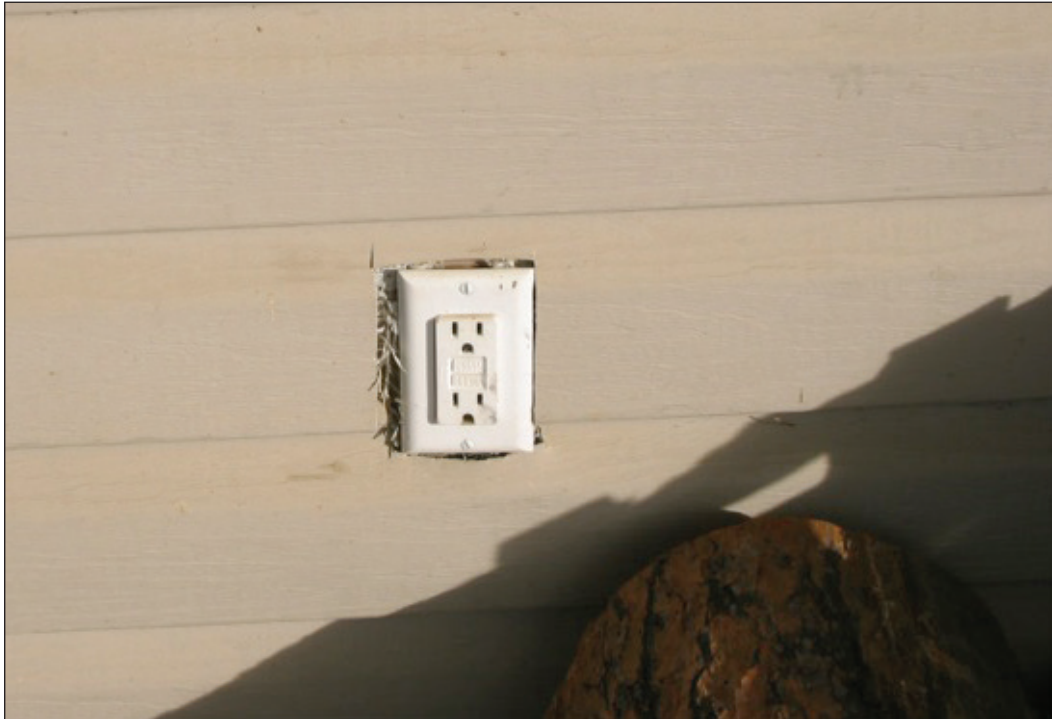
Defect Recognition – slide 7-01

1. The electrical GFI receptacle cover installed here is not permitted for exterior use.
2. The siding should extend behind the electrical cover (poor workmanship) and now presents a possible water leak issue.

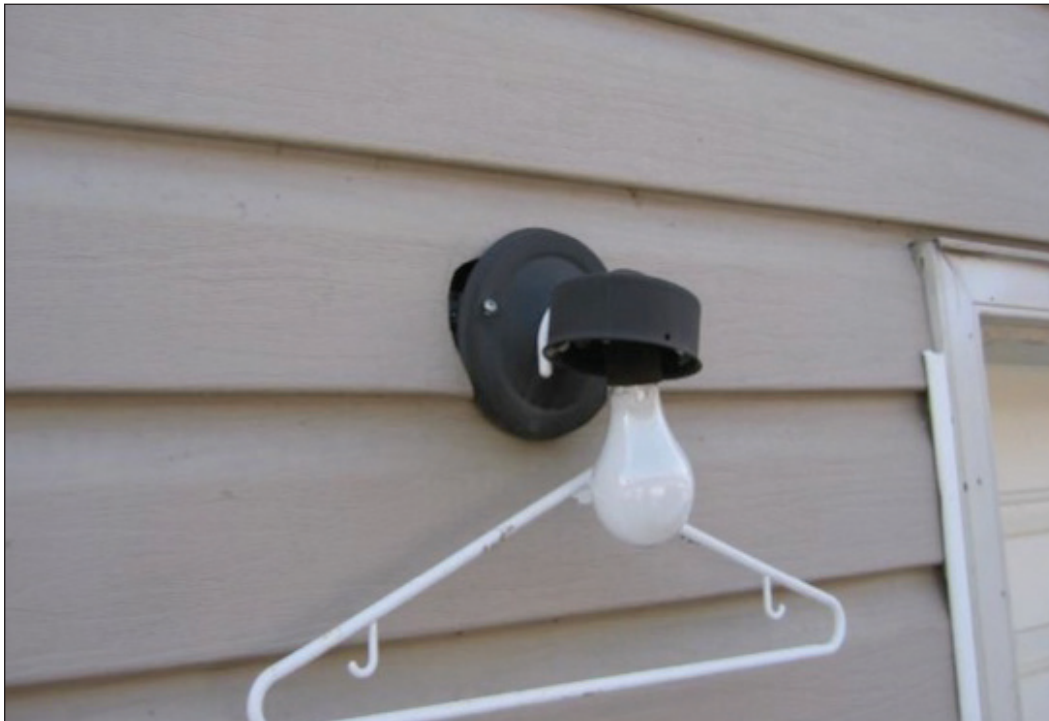
Defect Recognition – slide 7-02

The protective globe or cover on this light fixture has been broken or removed and the light bulb itself has been broken off the screw base.

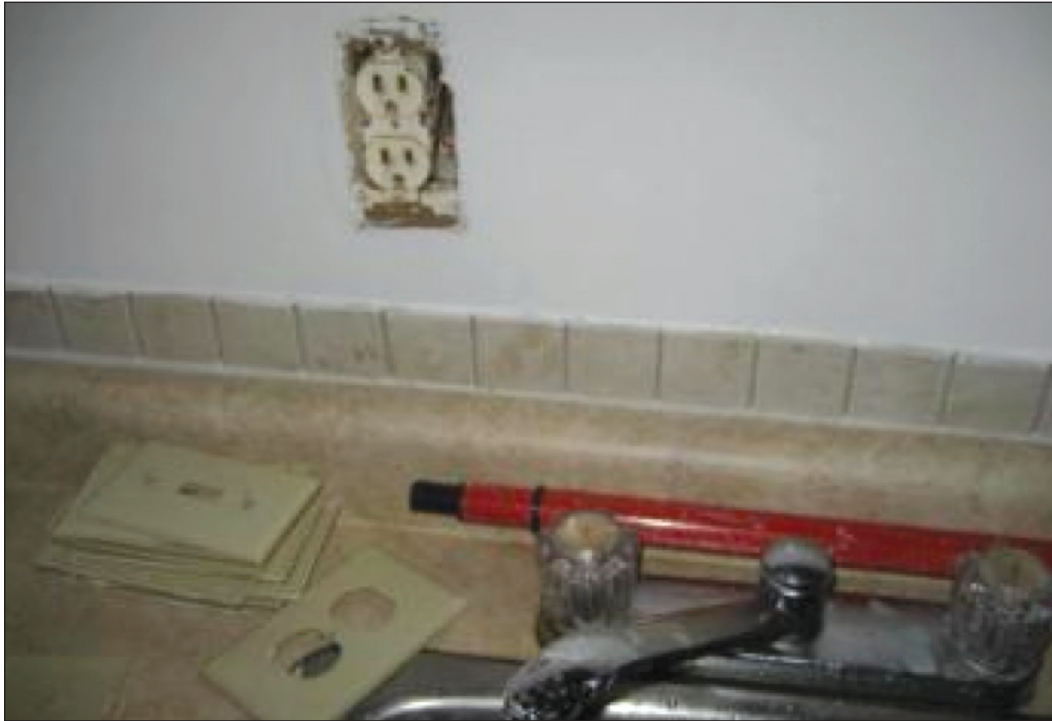
Defect Recognition – slide 7-03

This electrical receptacle is within 1 m (36 in.) of a water source (kitchen sink) and is not a ground-fault interrupter (GFI) receptacle. Also, the protective cover is missing on the electrical receptacle (plug).

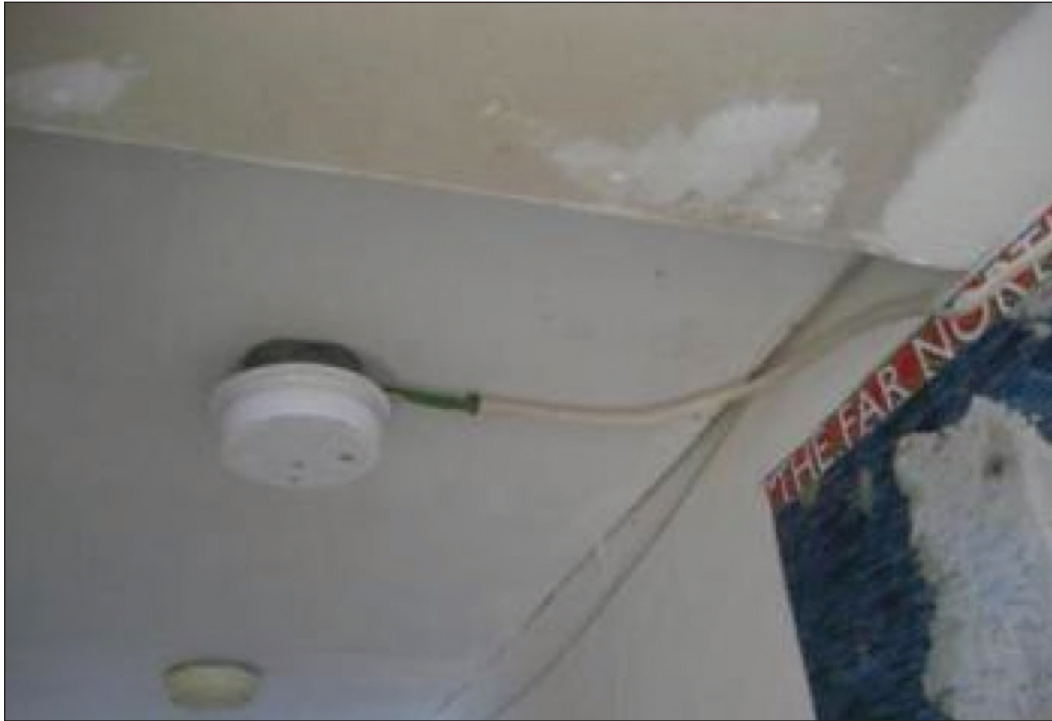
Defect Recognition – slide 7-04

1. Plastic-sheathed electrical wiring should not be exposed. It must be behind the drywall or be protected by being inside wiremold or BX (armoured) cable.
2. The smoke detector is not installed up against the ceiling.

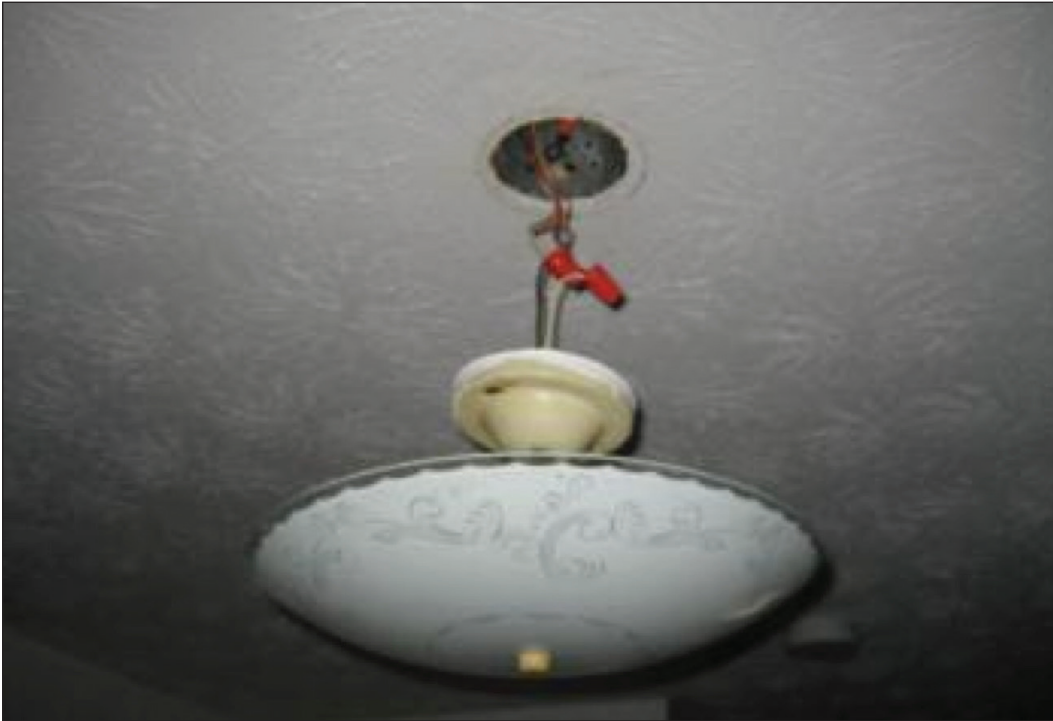
Defect Recognition – slide 7-05

The light fixture is hanging by its electrical wiring. This is dangerous and should be corrected right away.

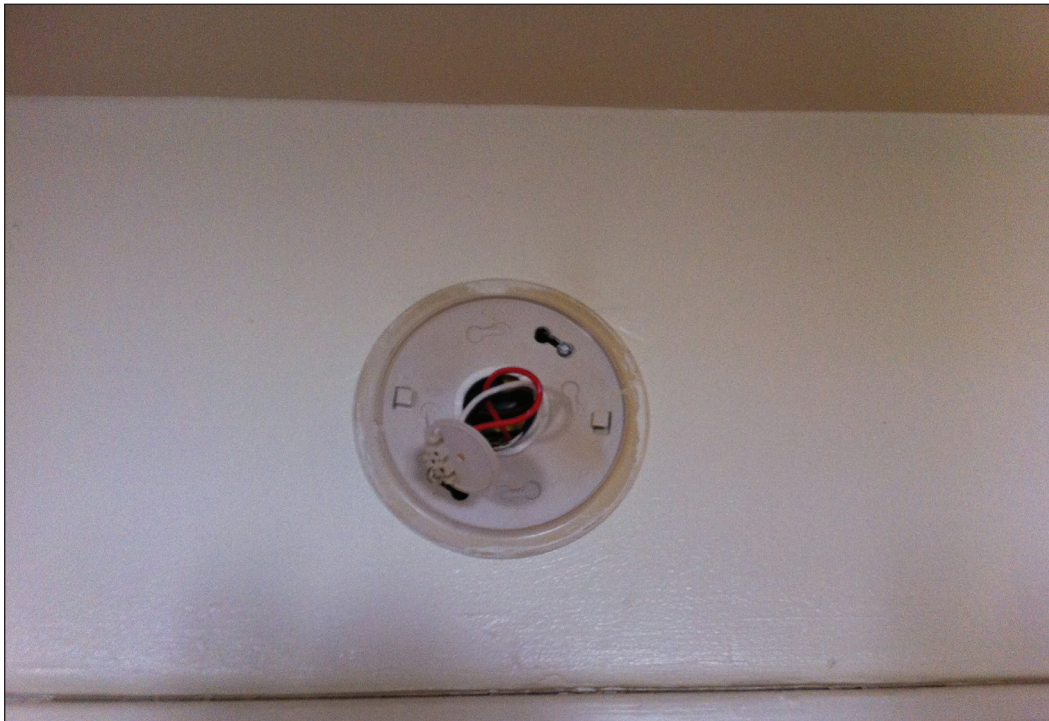
Defect Recognition – slide 7-06

The smoke detector is missing. Alarmingly, this is a common sight in houses in First Nation communities.

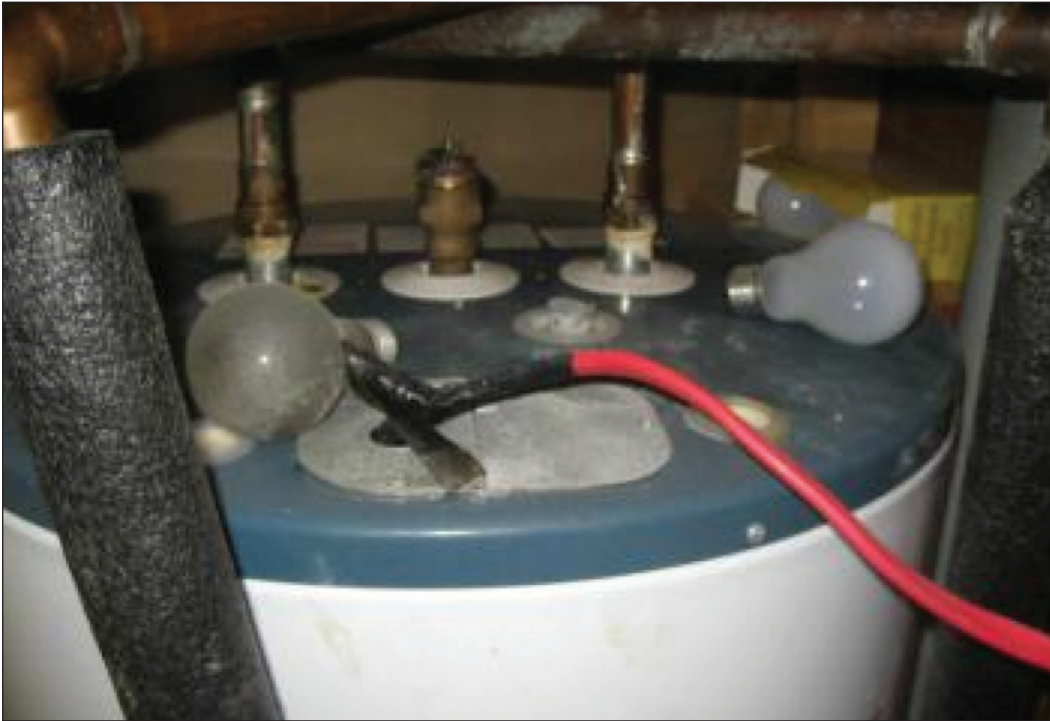
Defect Recognition – slide 7-07

An unprotected, plastic-sheathed electrical cable is being used to power the hot water heater. Also, the wire is running directly into the fixture.

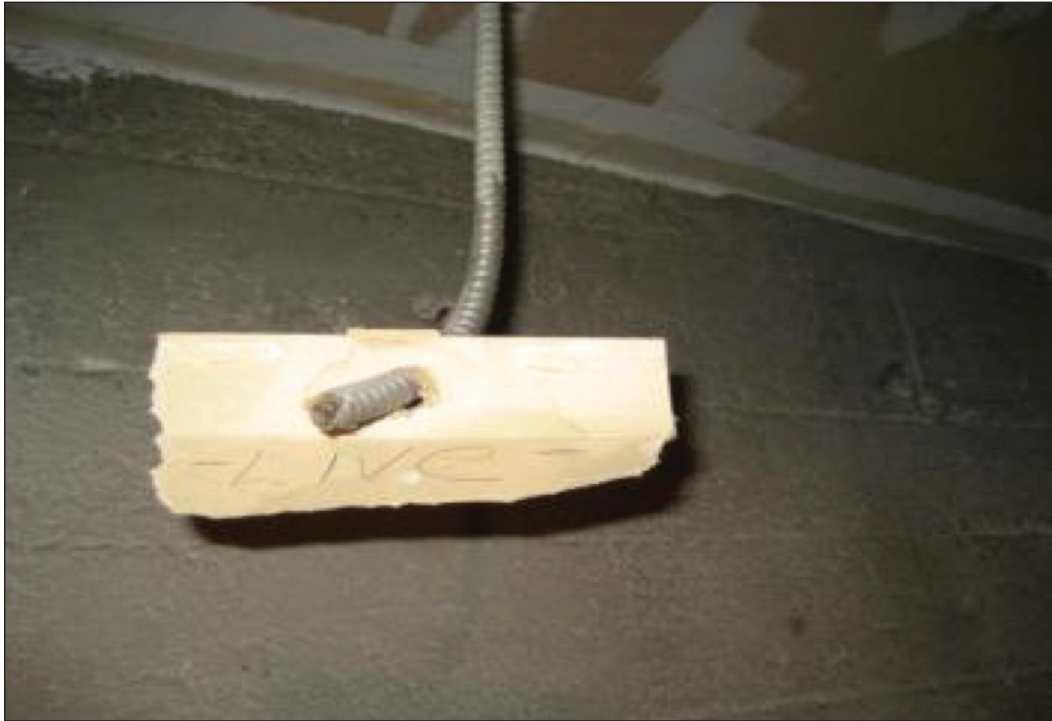
Defect Recognition – slide 7-08

A live electrical wire is exposed and presents a life-threatening hazard.

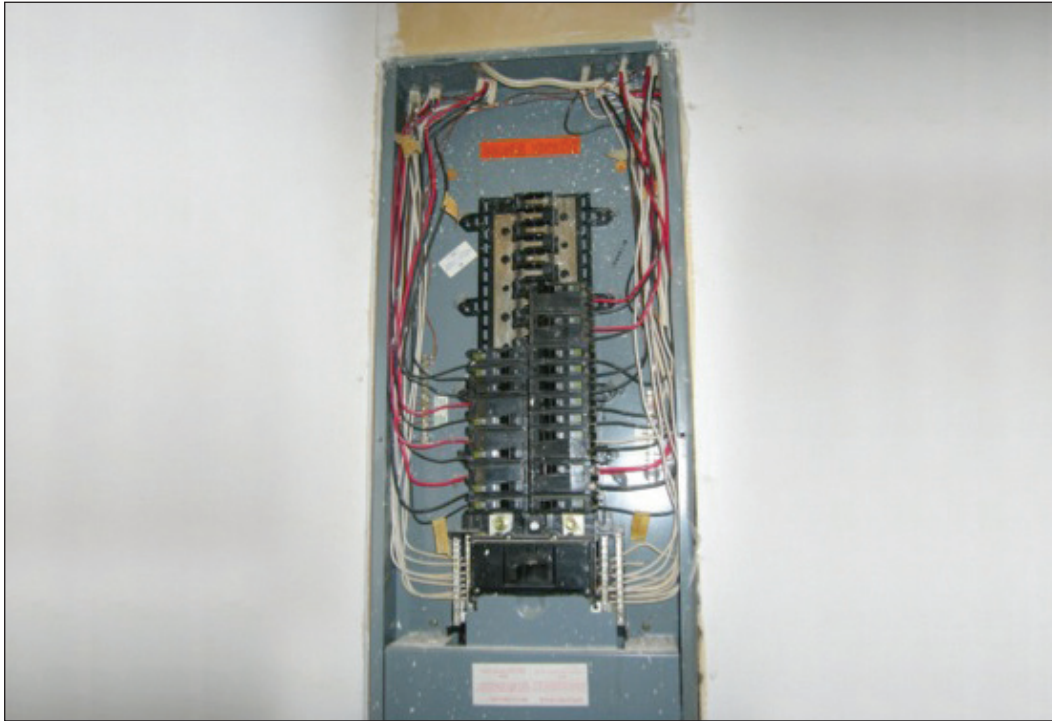
Defect Recognition – slide 7-09

The electrical panel is open and exposed. This is extremely dangerous and life-threatening.

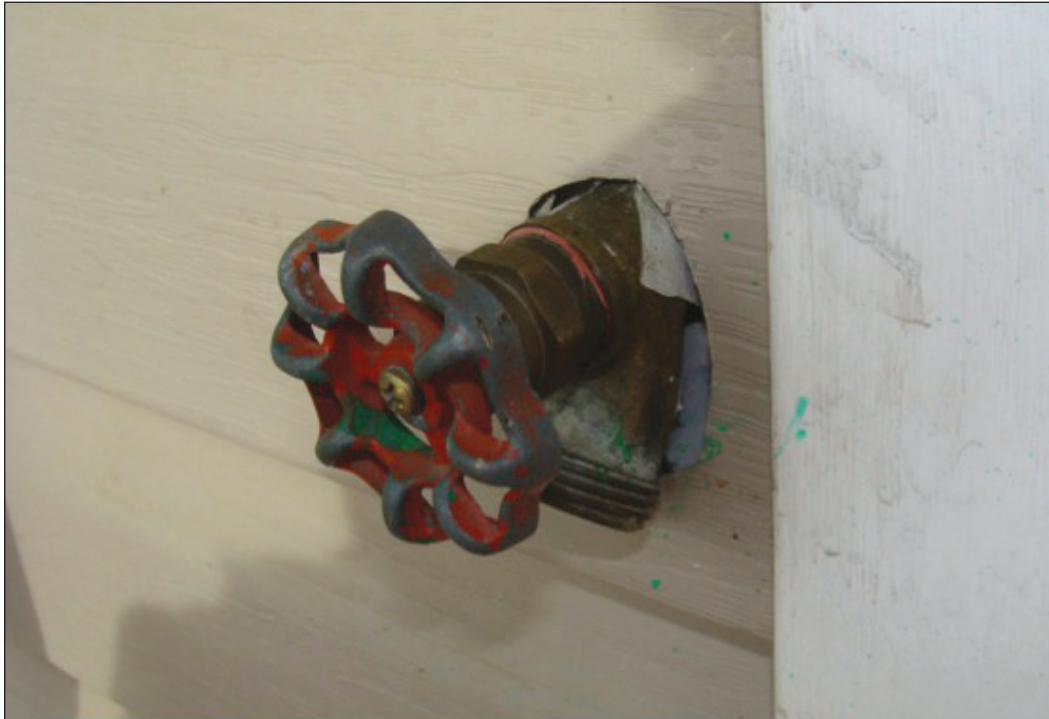
Defect Recognition – slide 8-01

The threaded end of the tap is too close to the wall to facilitate an easy connection of the garden hose. Also the tap itself is not a frost-protected valve, which could present a risk of freezing in cold areas.

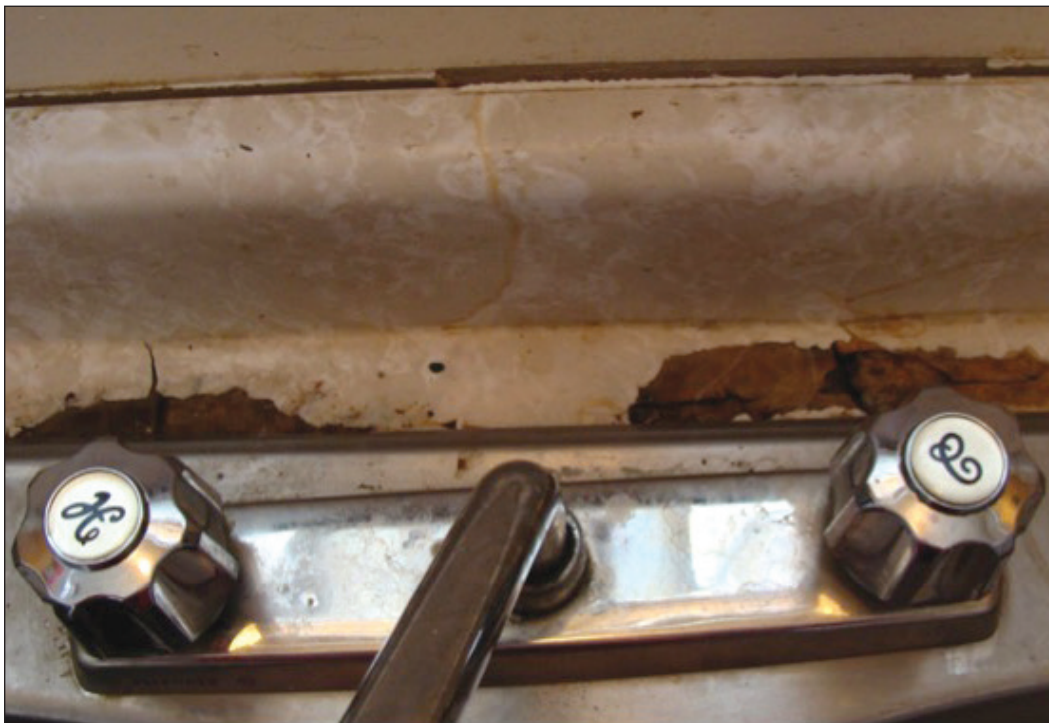
Defect Recognition – slide 8-02

The deck-mounted faucet has been leaking water over a long period of time causing the countertop to absorb water and swell and the Arborite™ surface to come off. There is likely some mould on the underside of this countertop.

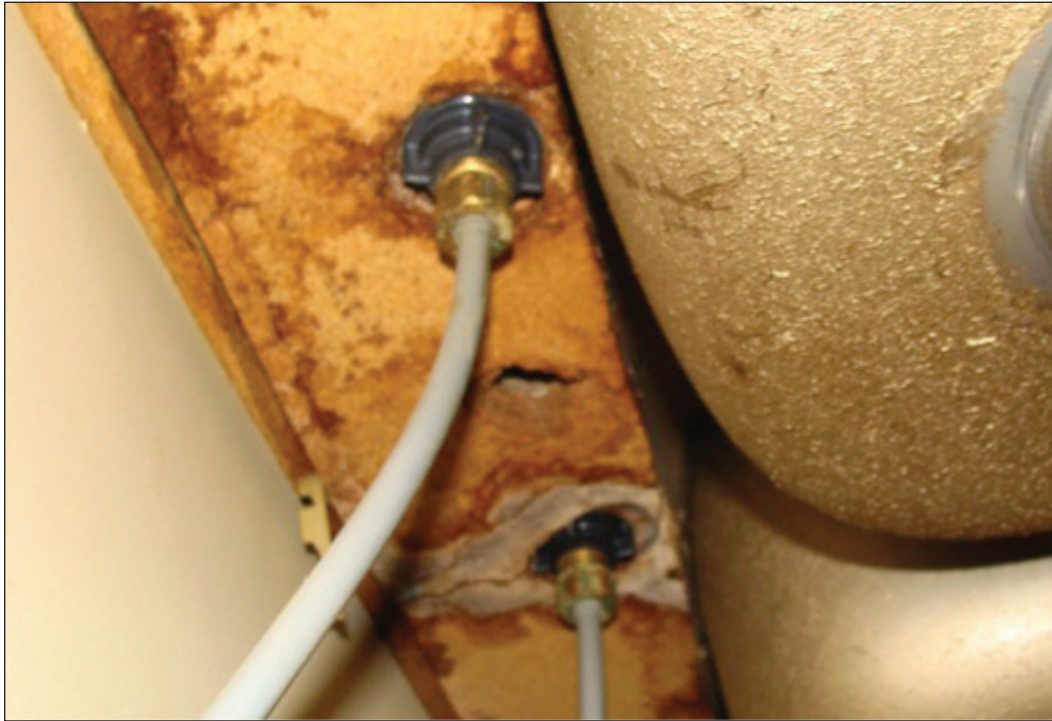
Defect Recognition – slide 8-03

There is some deterioration to the underside of this moulded countertop causing the faucet deck above to become loose. There is also some mould growth.

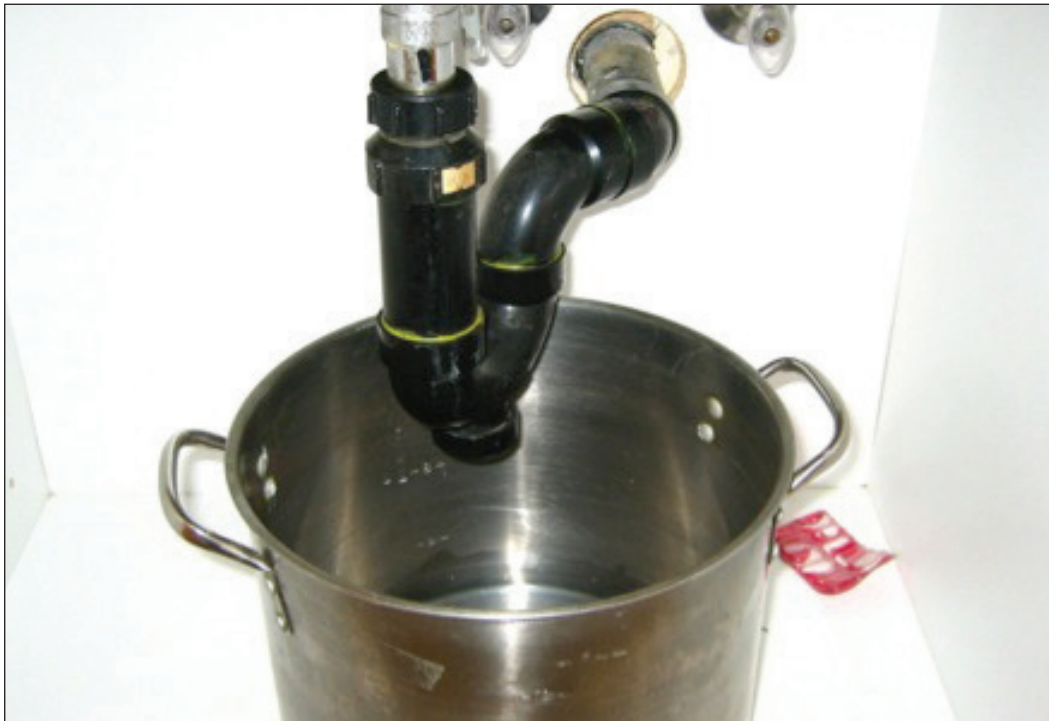
Defect Recognition – slide 8-04

The P-trap or drainpipe joints are leaking. The placement of the pot only buys some time to do the repair, but should not be considered a permanent fix.

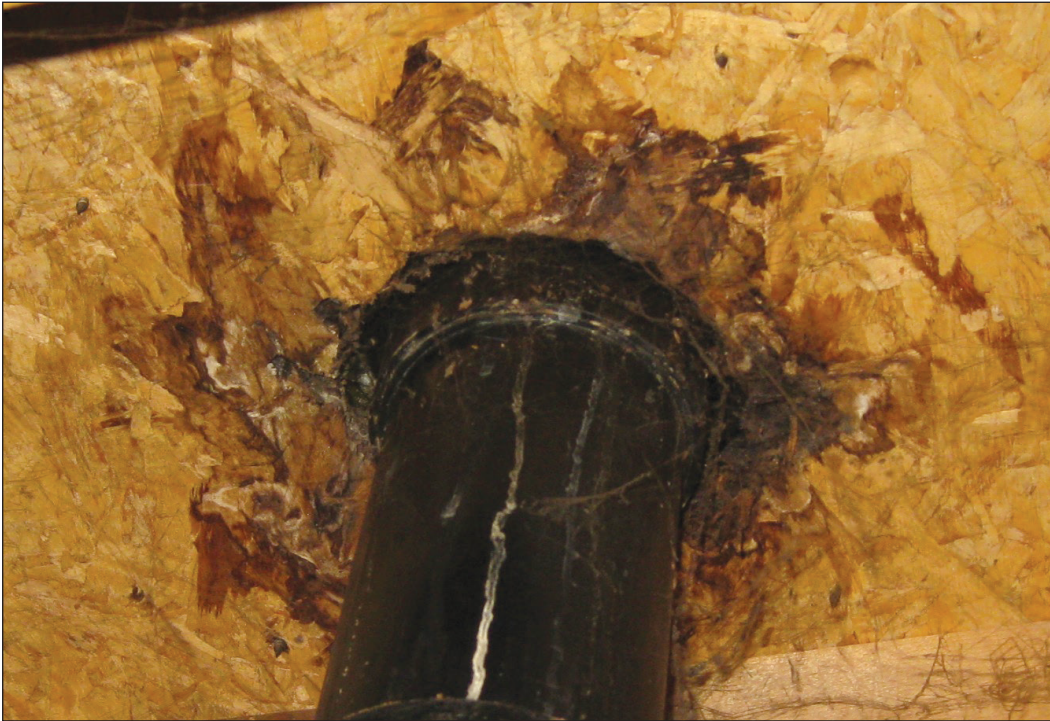
Defect Recognition – slide 8-05

Observation of the underside of the main floor, indicates a leak around the toilet seal.

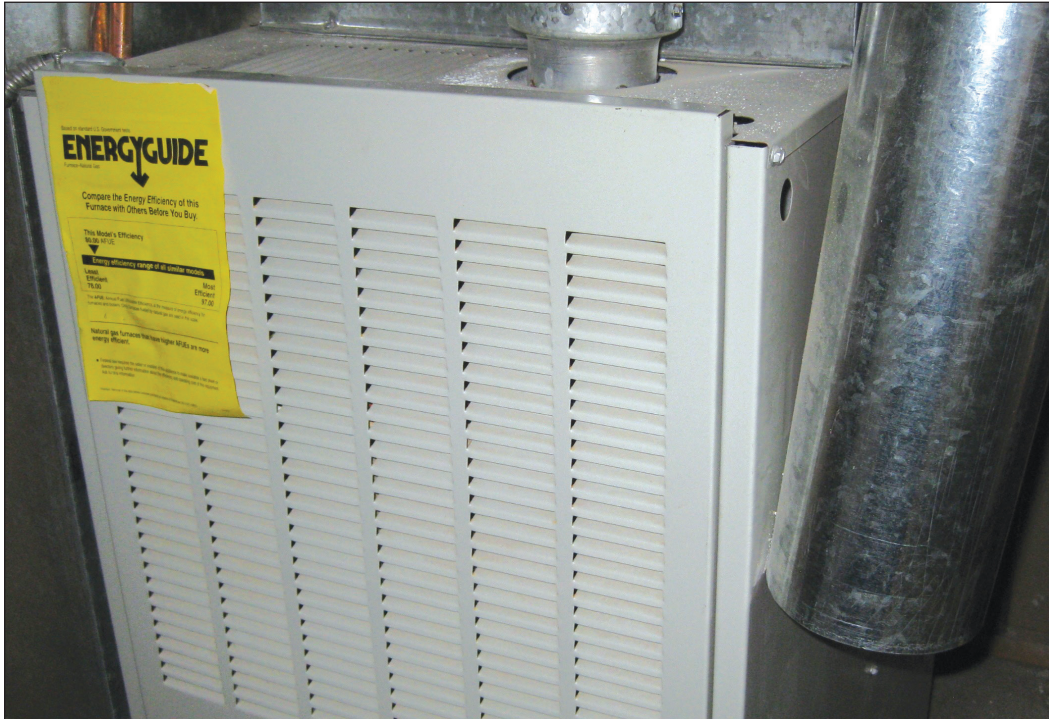
Defect Recognition – slide 9-01

There are a number of things that could go wrong with a forced-air furnace. If you are not an expert, you should not take it upon yourself to inspect heating appliances.

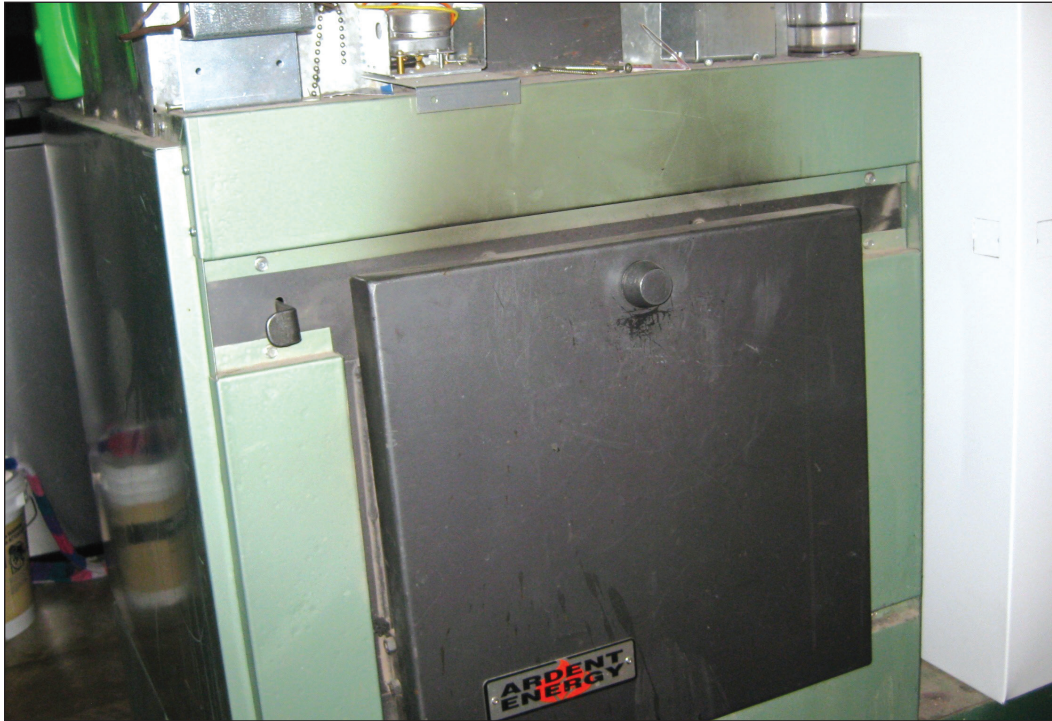
Defect Recognition – slide 9-02

There are a number of things that could go wrong with a wood-burning or combo forced-air furnace. If you are not an expert, you should not take it upon yourself to inspect heating appliances.

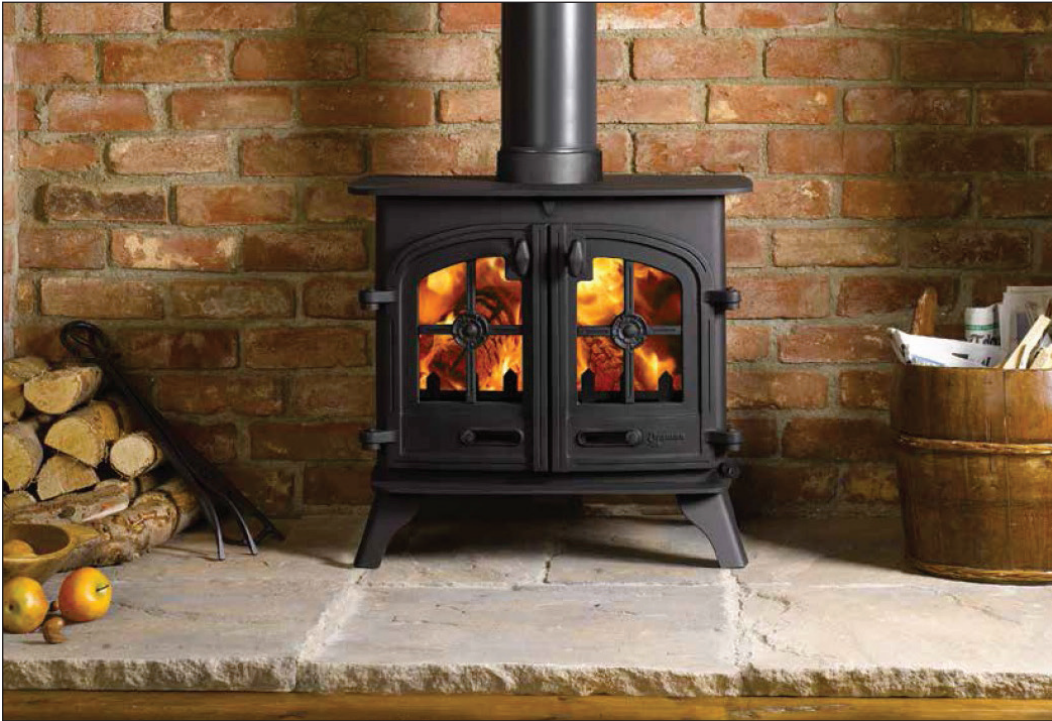
Defect Recognition – slide 9-03

There are a number of things that could go wrong with a wood stove. If you are not an expert, you should not take it upon yourself to inspect heating appliances.

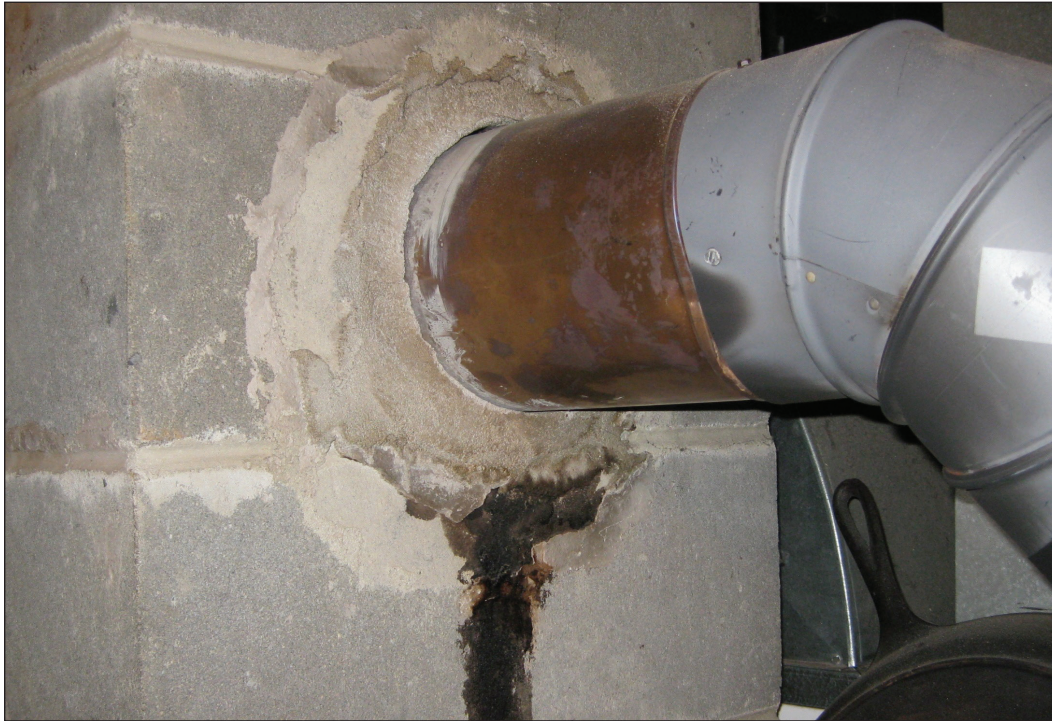
Defect Recognition – slide 9-04

Creosote is leaking out of the cemented connection of the metal chimney to the masonry chimney.

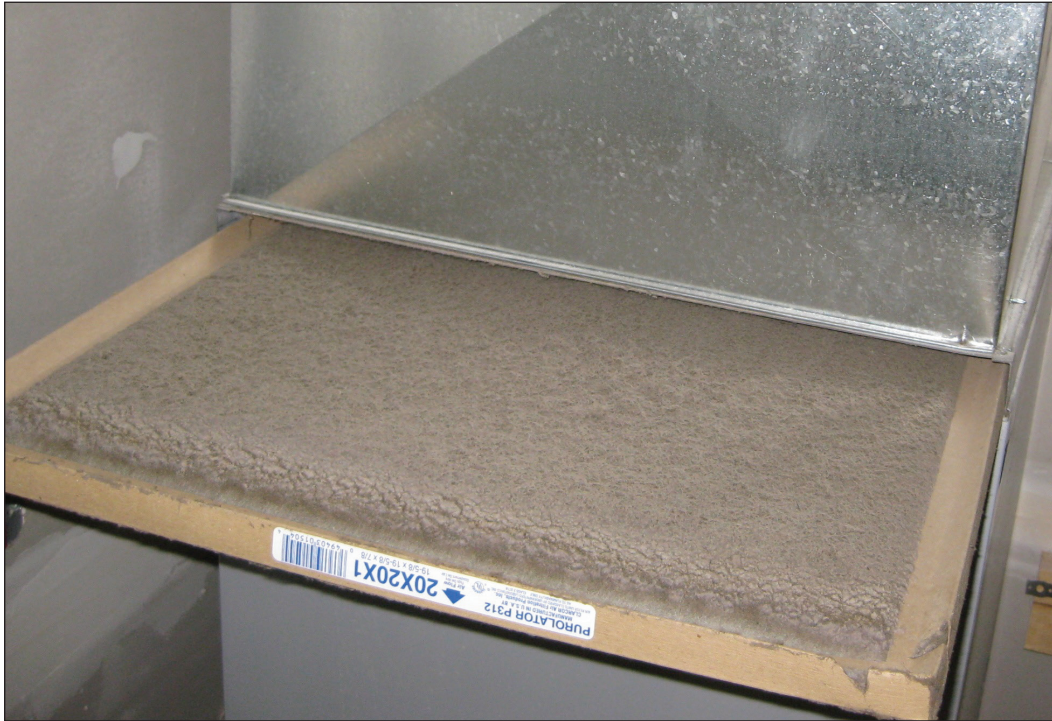
Defect Recognition – slide 9-05

This furnace air filter is clogged with dust and dirt.

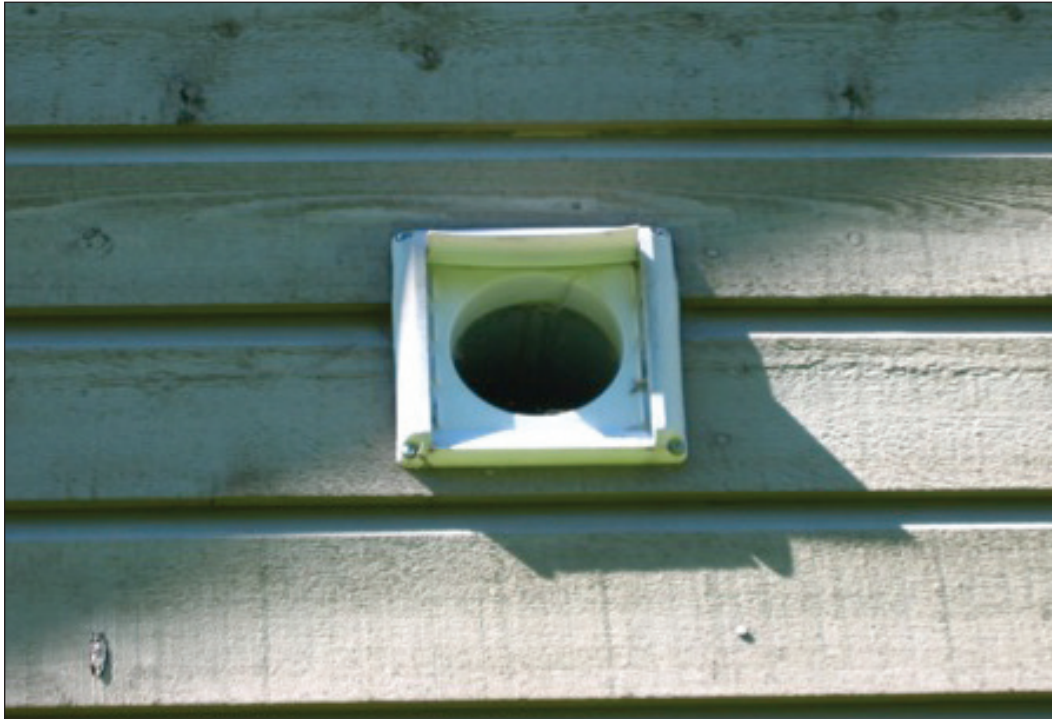
Defect Recognition – slide 10-01

This exhaust fan hood is missing the hood and flap that stops the wind and birds from going into the duct.

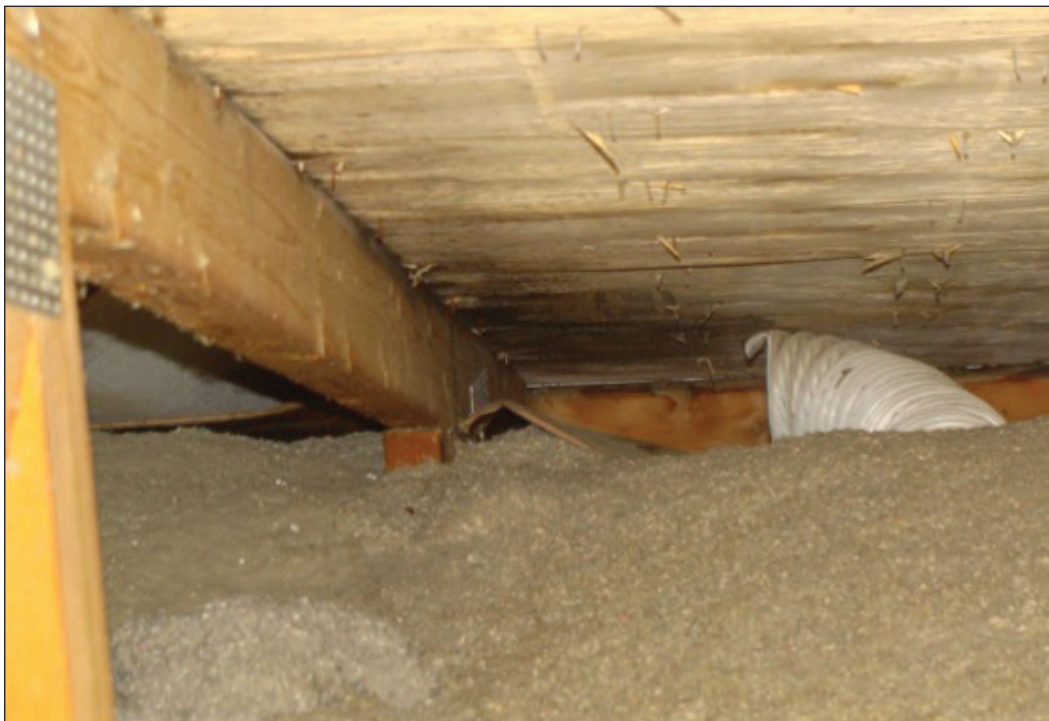
Defect Recognition – slide 10-02

This bathroom exhaust fan hose was terminated in the attic space. The Building Code requires all exhaust fans to be terminated on an exterior wall or through the roof. You can see evidence of the beginnings of moisture damage to the underside of the roof sheathing.

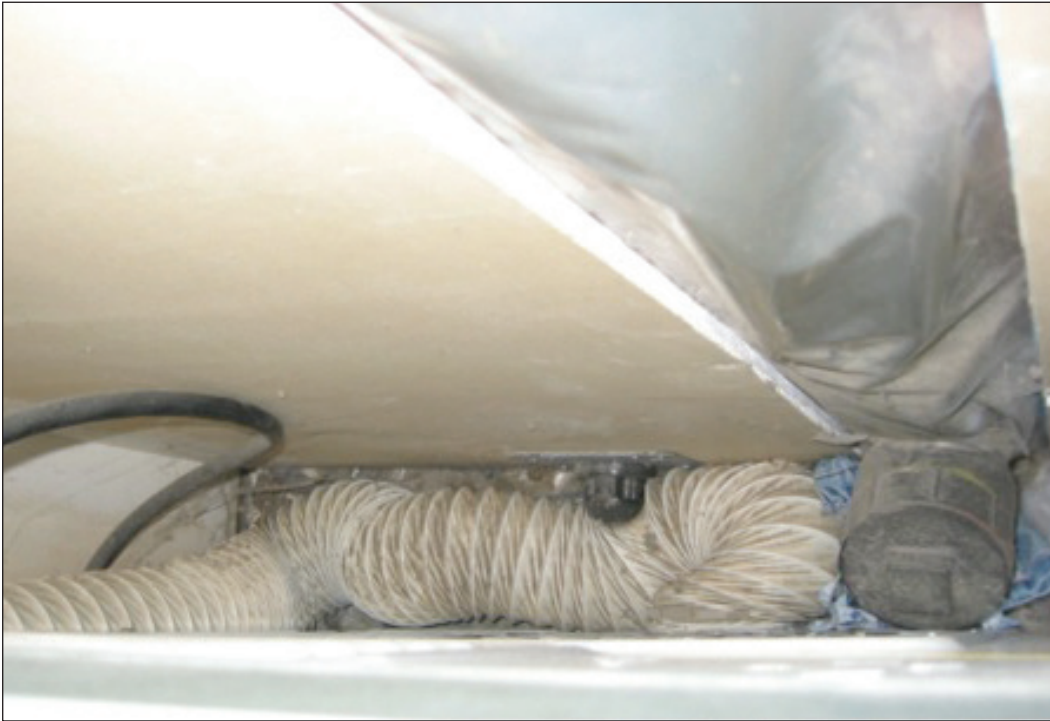
Defect Recognition – slide 10-03

A flexible plastic dryer exhaust hose has been installed. It is too long and has many tight curves that will restrict air flow and collect lint. This installation could become a fire hazard, as the plastic piping will heat up considerably and possibly begin to melt.

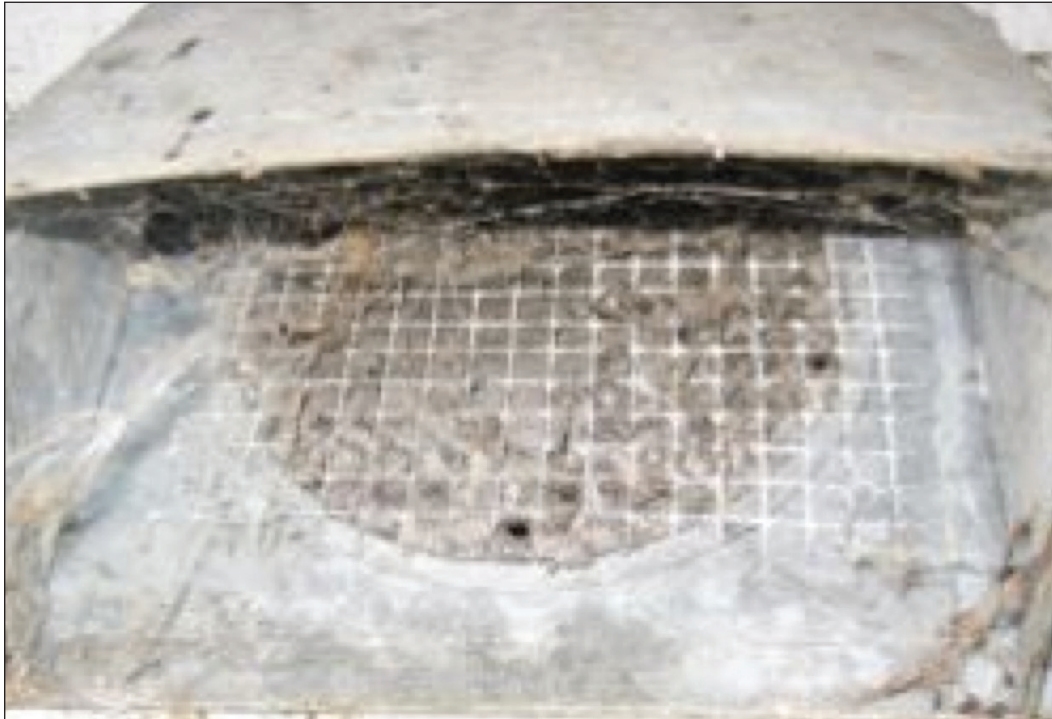
Defect Recognition – slide 10-04

This exterior dryer exhaust hood is completely plugged with lint.

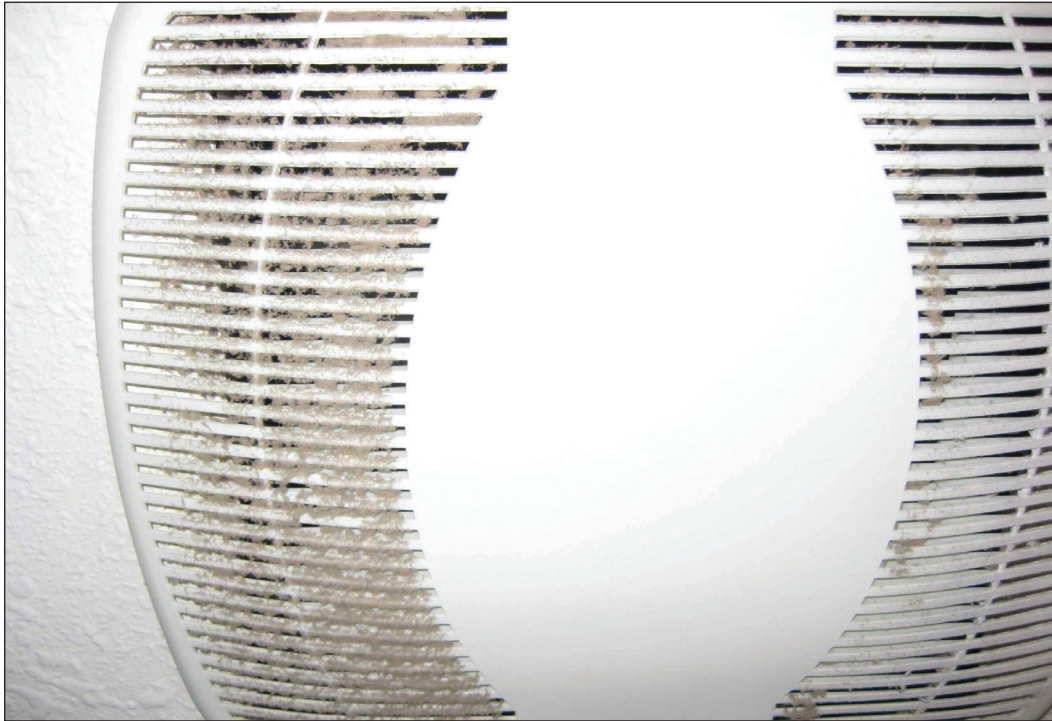
Defect Recognition – slide 10-05

This is a bathroom ceiling exhaust fan grille that is becoming clogged with dirt.
